REPORT OF CRITICAL EXAMINATION FOR MAINTENANCE AND REPAIRS OF EXTERIOR WALLS AND ENCLOSURES

200 MAIN Street

WEST CHICAGO, ILLINOIS, 60185-2837

REPORT SUBMITTAL DATE: 20.SEPTEMBER.2015

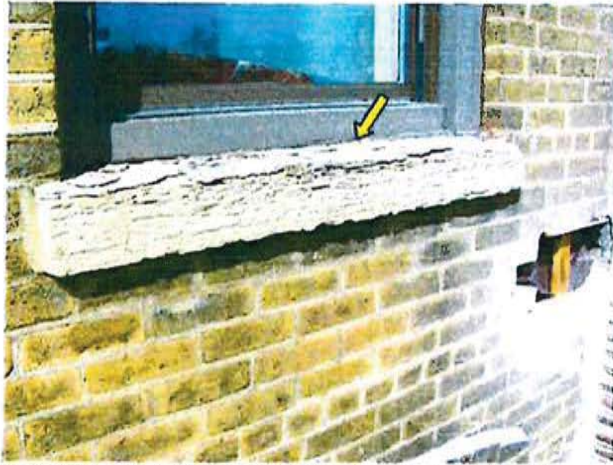
FR.12 / Main (East) Street Existing Deteriorated Sandstone Window Sill.

All of the existing Sandstone Window Sills will require that they be replaced due to excessive deterioration. Possible water infiltration may occur over the future freeze/thaw cycles causing significant damage.

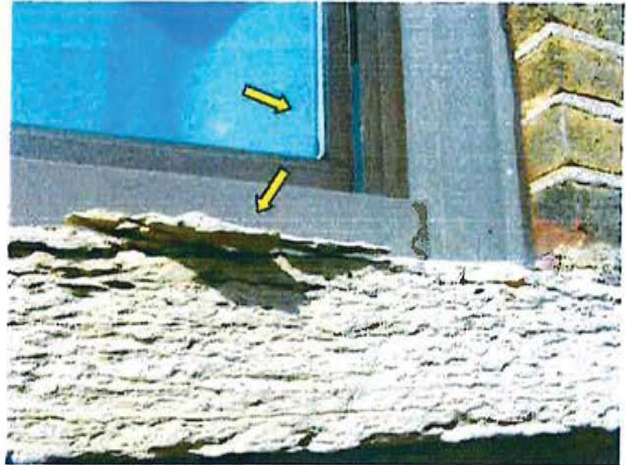
FR.13 / Main (East) Street Existing Deteriorated Sandstone Window Sill. Replacement Aluminum Windows.

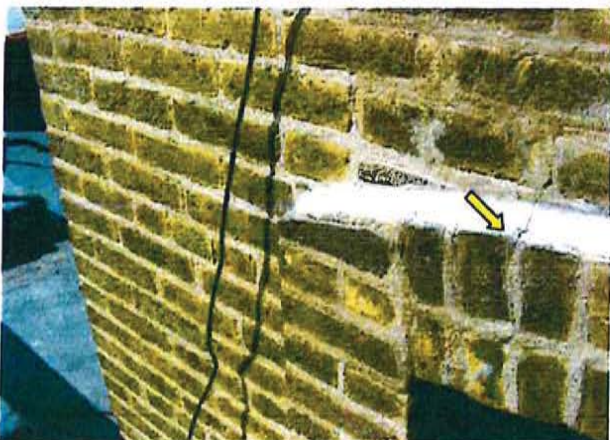
FR.16 / Main (East) Street Elevation, Masonry Stress @ Arch, Southwest Corner, Floor 2 @ Head.

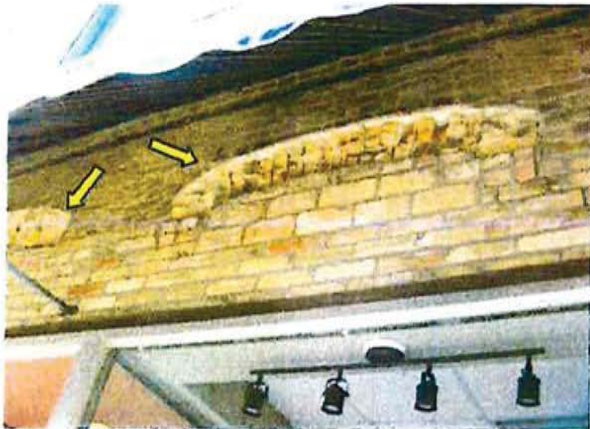
FR.21 / Main (East) Street Elevation, Level One Removed
Masonry Arch.

The masonry Arch Distress, Floor 2, (South Location) should be removed and rebuilt. The Level One (Main Street @ Grade) Original masonry Arches that have been removed should be replaced. The Level One Stone Veneer Storefronts are not original.

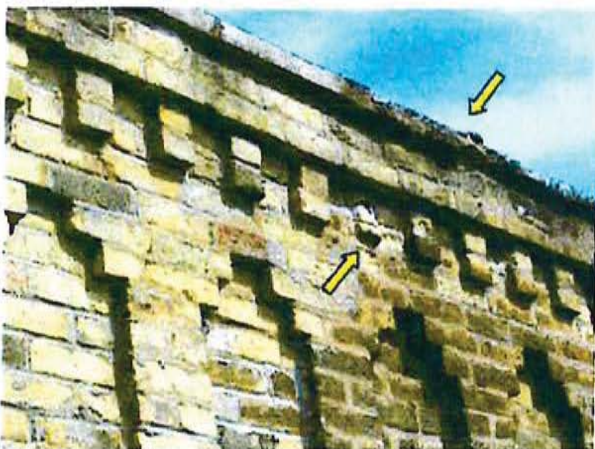
FR.26 / South Elevation, Deteriorated Masonry & Limestone Parapet Cap.

Various portions of the North, South, and West existing Limestone Cap should be replaced with a new cut Limestone Cap that also incorporates a drip edge. Possible water infiltration may occur over the future freeze/thaw cycles causing significant damage.

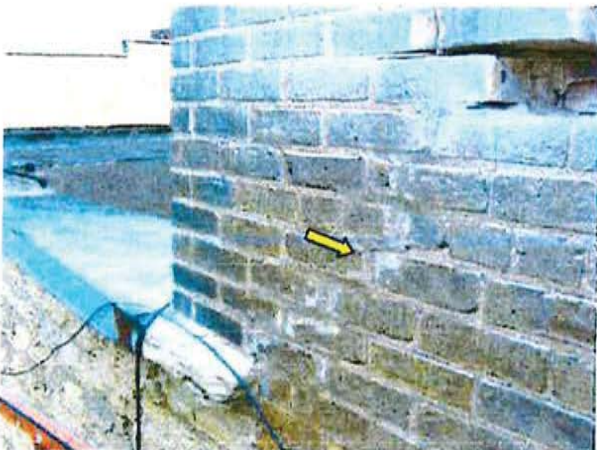
FR.31 / Turner (West) Court Elevation, Masonry Stress, Floor 3 (North),

The Floor 3 Parapet (Southwest Corner) has deteriorated due to differential movement including water infiltration over a period of time and should be removed and rebuilt. The masonry Stress Crack, Floor 3, (North Location) should be removed and rebuilt. The masonry Arch Distress, Floor 2, (South Location) should be removed and rebuilt. The deteriorated masonry Arch and masonry Stress Crack (Deteriorated Repair), Floor 1 above grade @ Fire Escape should be removed and rebuilt.

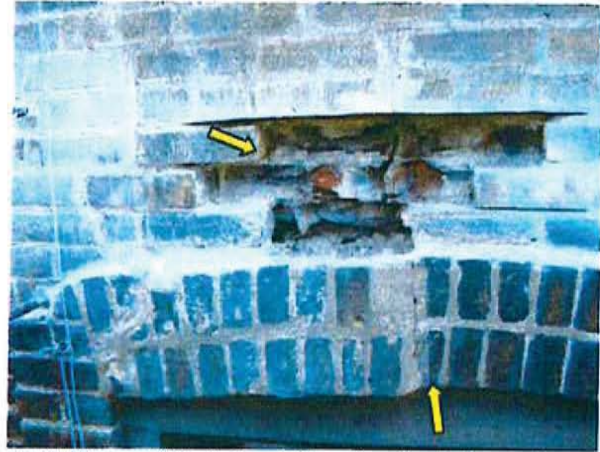
FR.33 / Turner (West) Court Elevation, South Inspection Opening, Floor 2. Masonry Arch Distress.

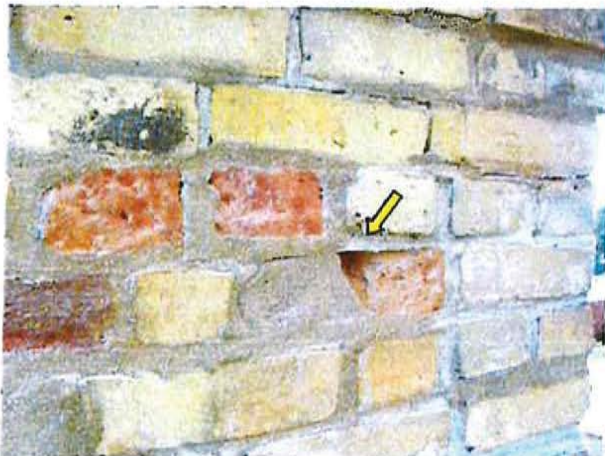
FR.34 / Turner (West) Court Elevation, Deteriorated Repair, South Corner, Floor 3 @ Head.

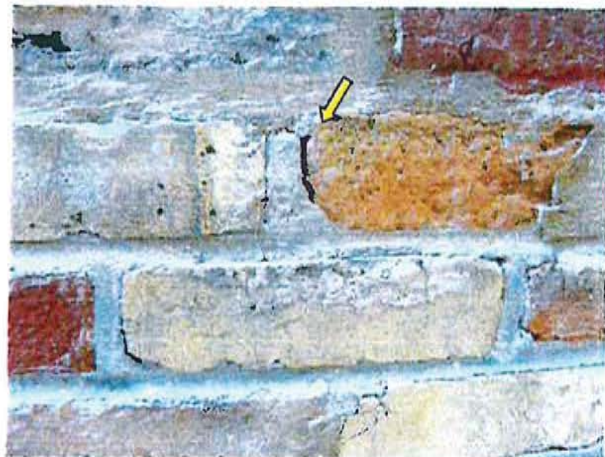
FR.35 / Turner (West) Court Elevation, Deteriorated Repair, South Corner, Floor 3 @ Head (Close-up).

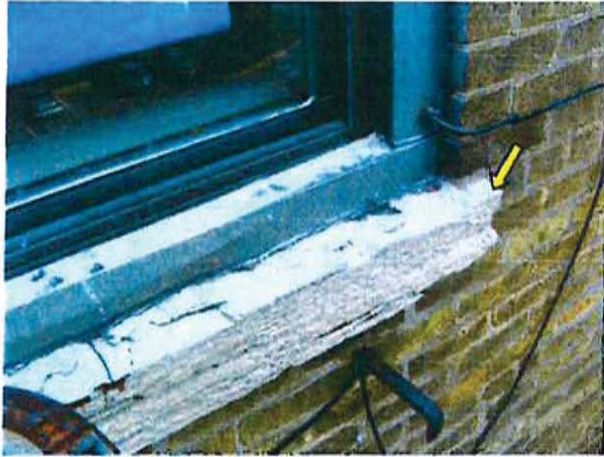
FR.37 / Turner (West) Court Elevation, Existing Deteriorated Sandstone Window Sill, North, Floor 3.

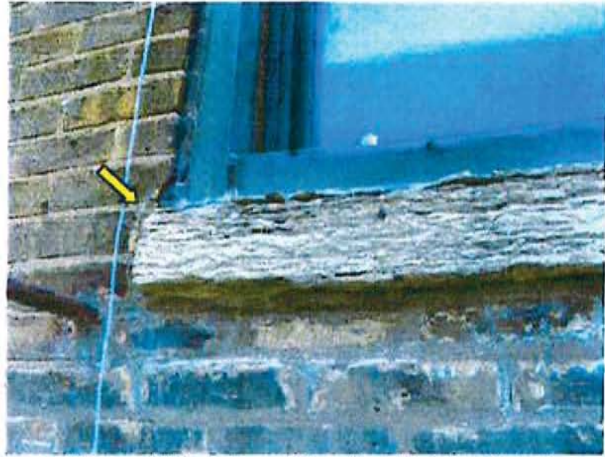
FR.38 / Turner (West) Court Elevation, Existing Deteriorated Sandstone Window Sill, South, Floor 3.

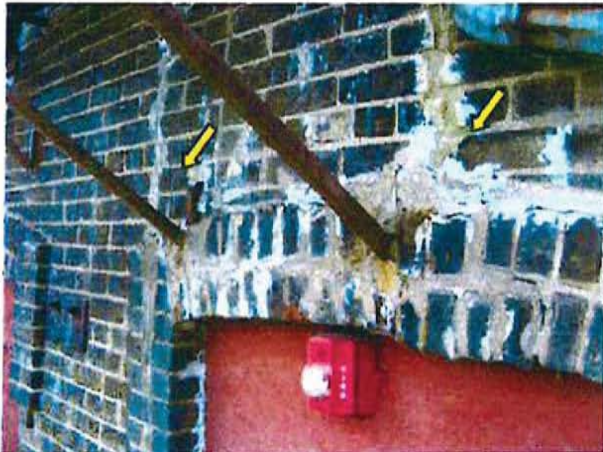
FR.39 / Turner (West) Court Elevation, Deteriorated Repair, Floor 1 Above Grade Level @ Fire Escape.

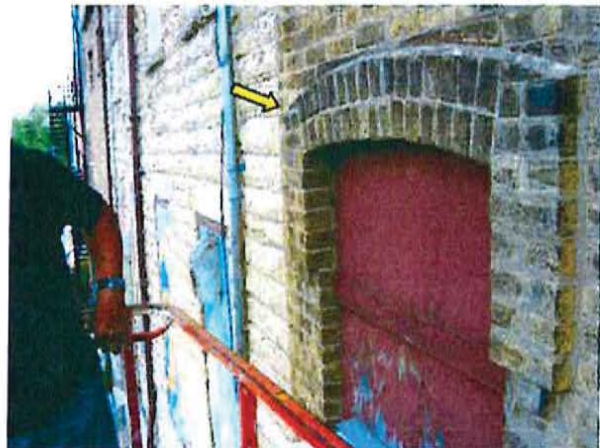
FR.40 / Turner (West) Court Elevation, Masonry Pointing, Required, Floor 1 (North) Above Grade Level.

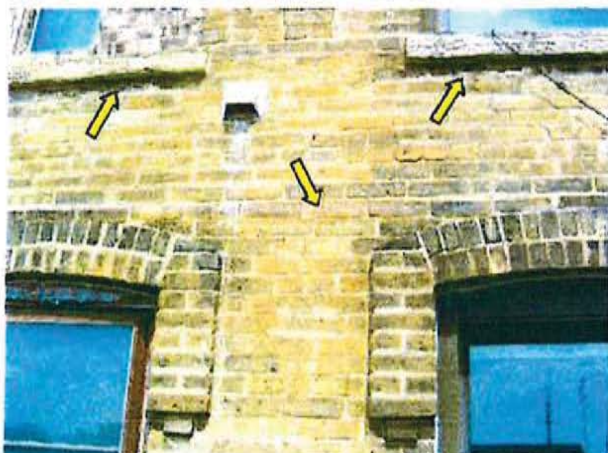
FR.41 / South Elevation, Deteriorated Limestone Sills, Masonry Pointing Required.

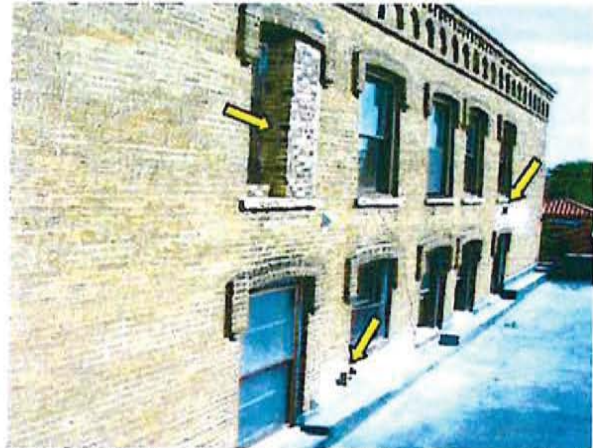
FR.43 / South Elevation, Masonry Infill @ Removed Window.
Inspection Openings, Floor 2 & 3.

The West Corner has deteriorated due to differential movement including water infiltration over a period of time and should be removed and rebuilt. The Floor 3 replaced window was infilled with masonry and should be removed. Much of the Existing Parapet Corbel-Table with masonry Dentils in the Bed Mould of the Cornice require repair and pointing. This would also include the replacement of the deteriorated Limestone Caps and Sandstone Window Sills. The entire South Elevation should be pointed. The future Maintenance Repairs must be considered permanent in nature and must be intended to bring any condition into a state of reliability. The objective of all Maintenance Repairs should be to limit deterioration through early intervention.

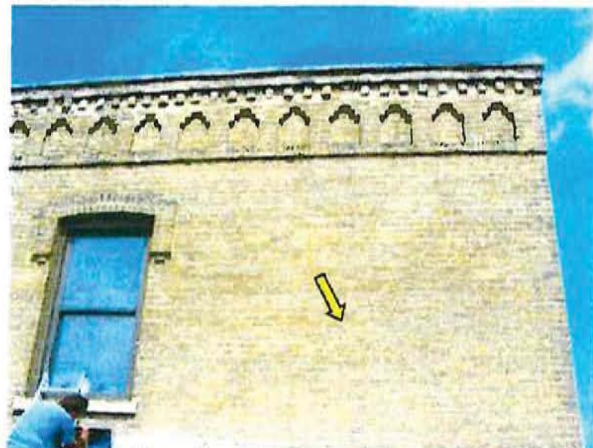
FR.45 / South Elevation (East Corner), Masonry Pointing
Required.

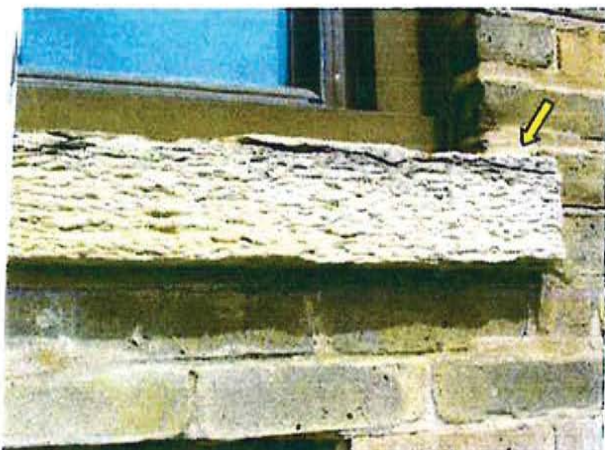
FR.51 / South Elevation, Deteriorated Limestone Sill, Floor 3.

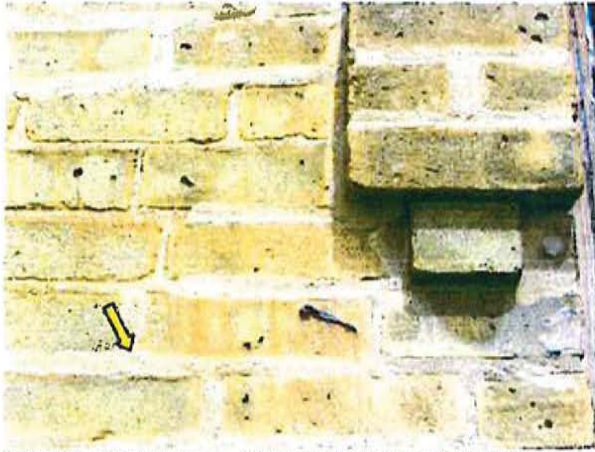
FR.52 / South Elevation, Masonry Pointing Required, Floor 2.

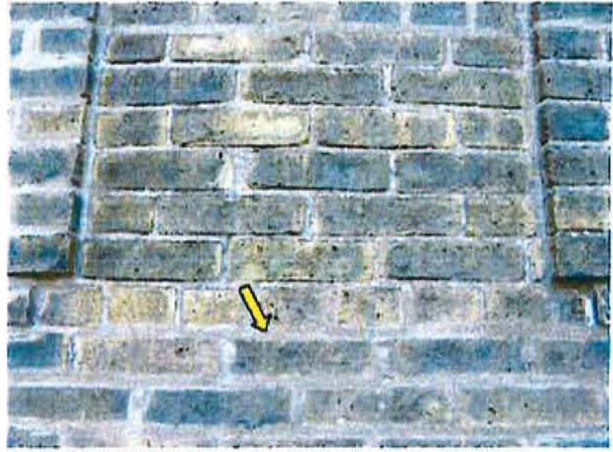
FR.53 / North Elevation, Masonry Pointing Required, Floor 3.

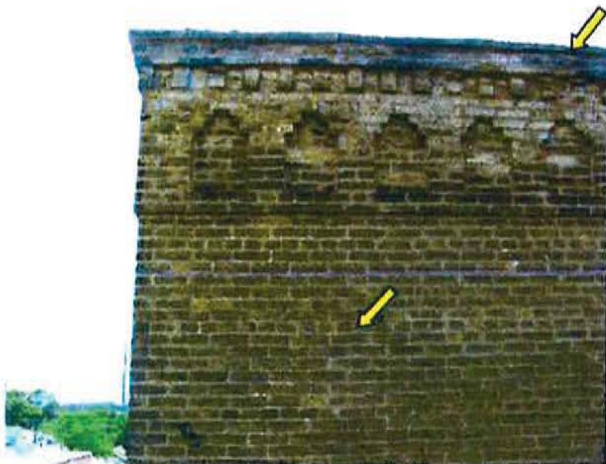
FR.56 / North Elevation, Masonry Pointing Required, Floor 3.
Deteriorated Limestone Sill.

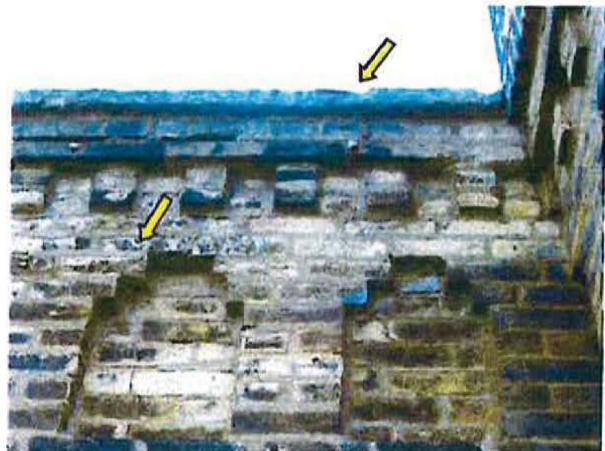
FR.60 / North Elevation, Deteriorated Limestone Cap & Masonry.

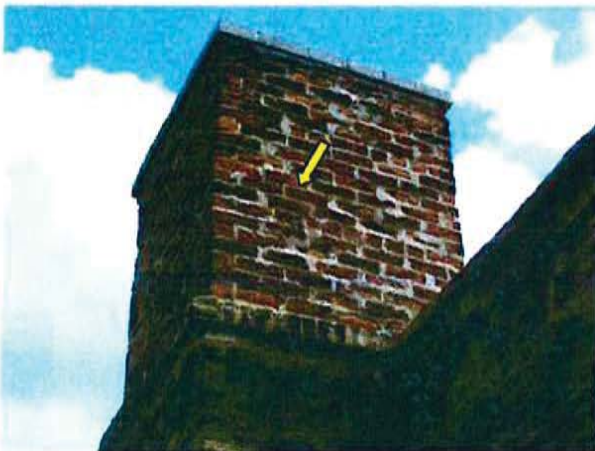
FR.61 / North Elevation, Deteriorated Chimney Masonry,
All Elevations.

The Existing previously lowered and replaced Chimney Cap (All Elevations) has further deteriorated and should be removed and replaced.

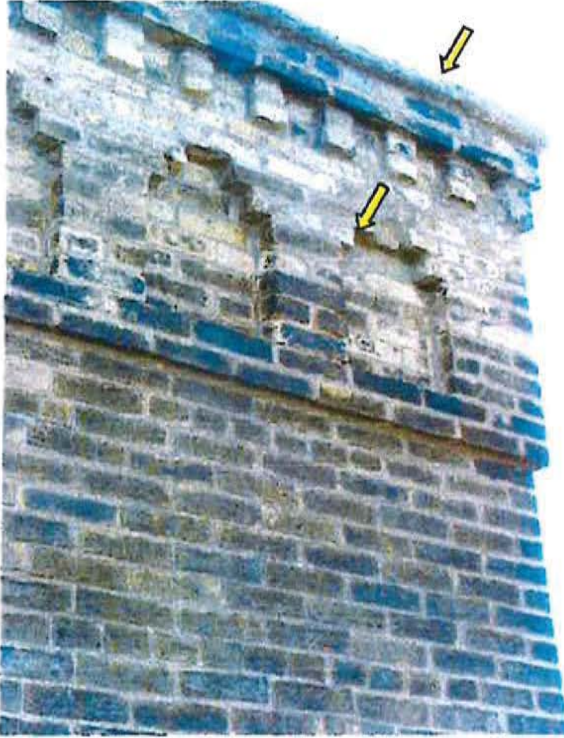
FR.62 / North Elevation, Deteriorated Limestone Cap & Masonry.

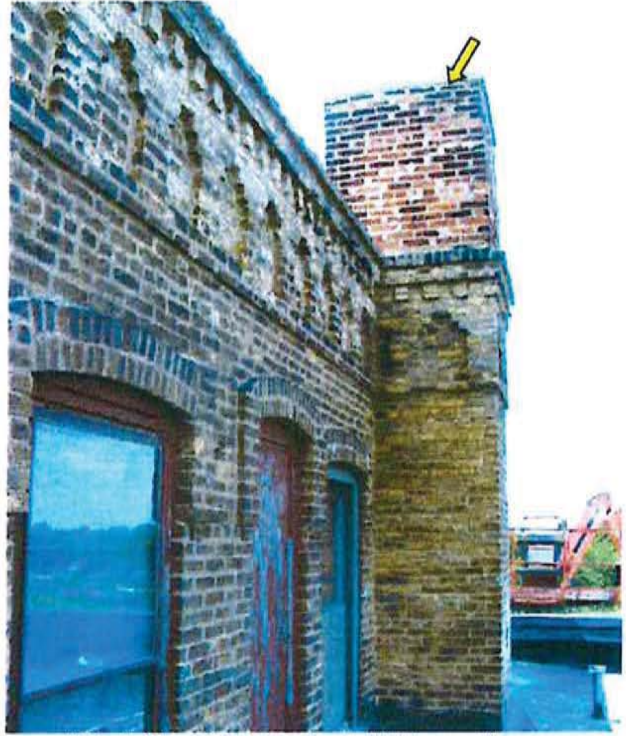
FR.63 / North Elevation, Deteriorated Chimney Masonry, All Elevations.

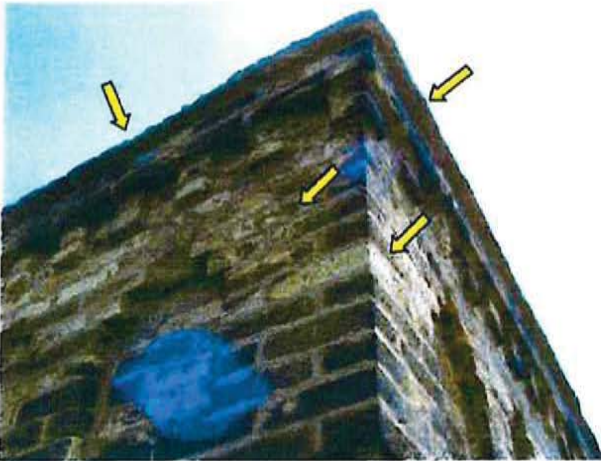
FR.64 / North Elevation, West Corner, Deteriorated Limestone Cap & Masonry.
