**PRELIMINARY OPINION of PROBABLE COST - DETAIL**  
**RENOVATE 200 MAIN STREET BUILDING**  
**WEST CHICAGO, ILLINOIS**  
**MATOCHA PROJECT NO.: 1506.01**  
**DATE: NOVEMBER 9, 2015**

**STRUCTURAL REPAIRS**

Re: 200 W. Main Street  
West Chicago, Illinois

On August 12, 2015 we visited the above referenced site to observe the structural condition of the above referenced building. The structure consists of a three story wood framed structure with perimeter load-bearing masonry walls. The following is an itemized list of our observations.

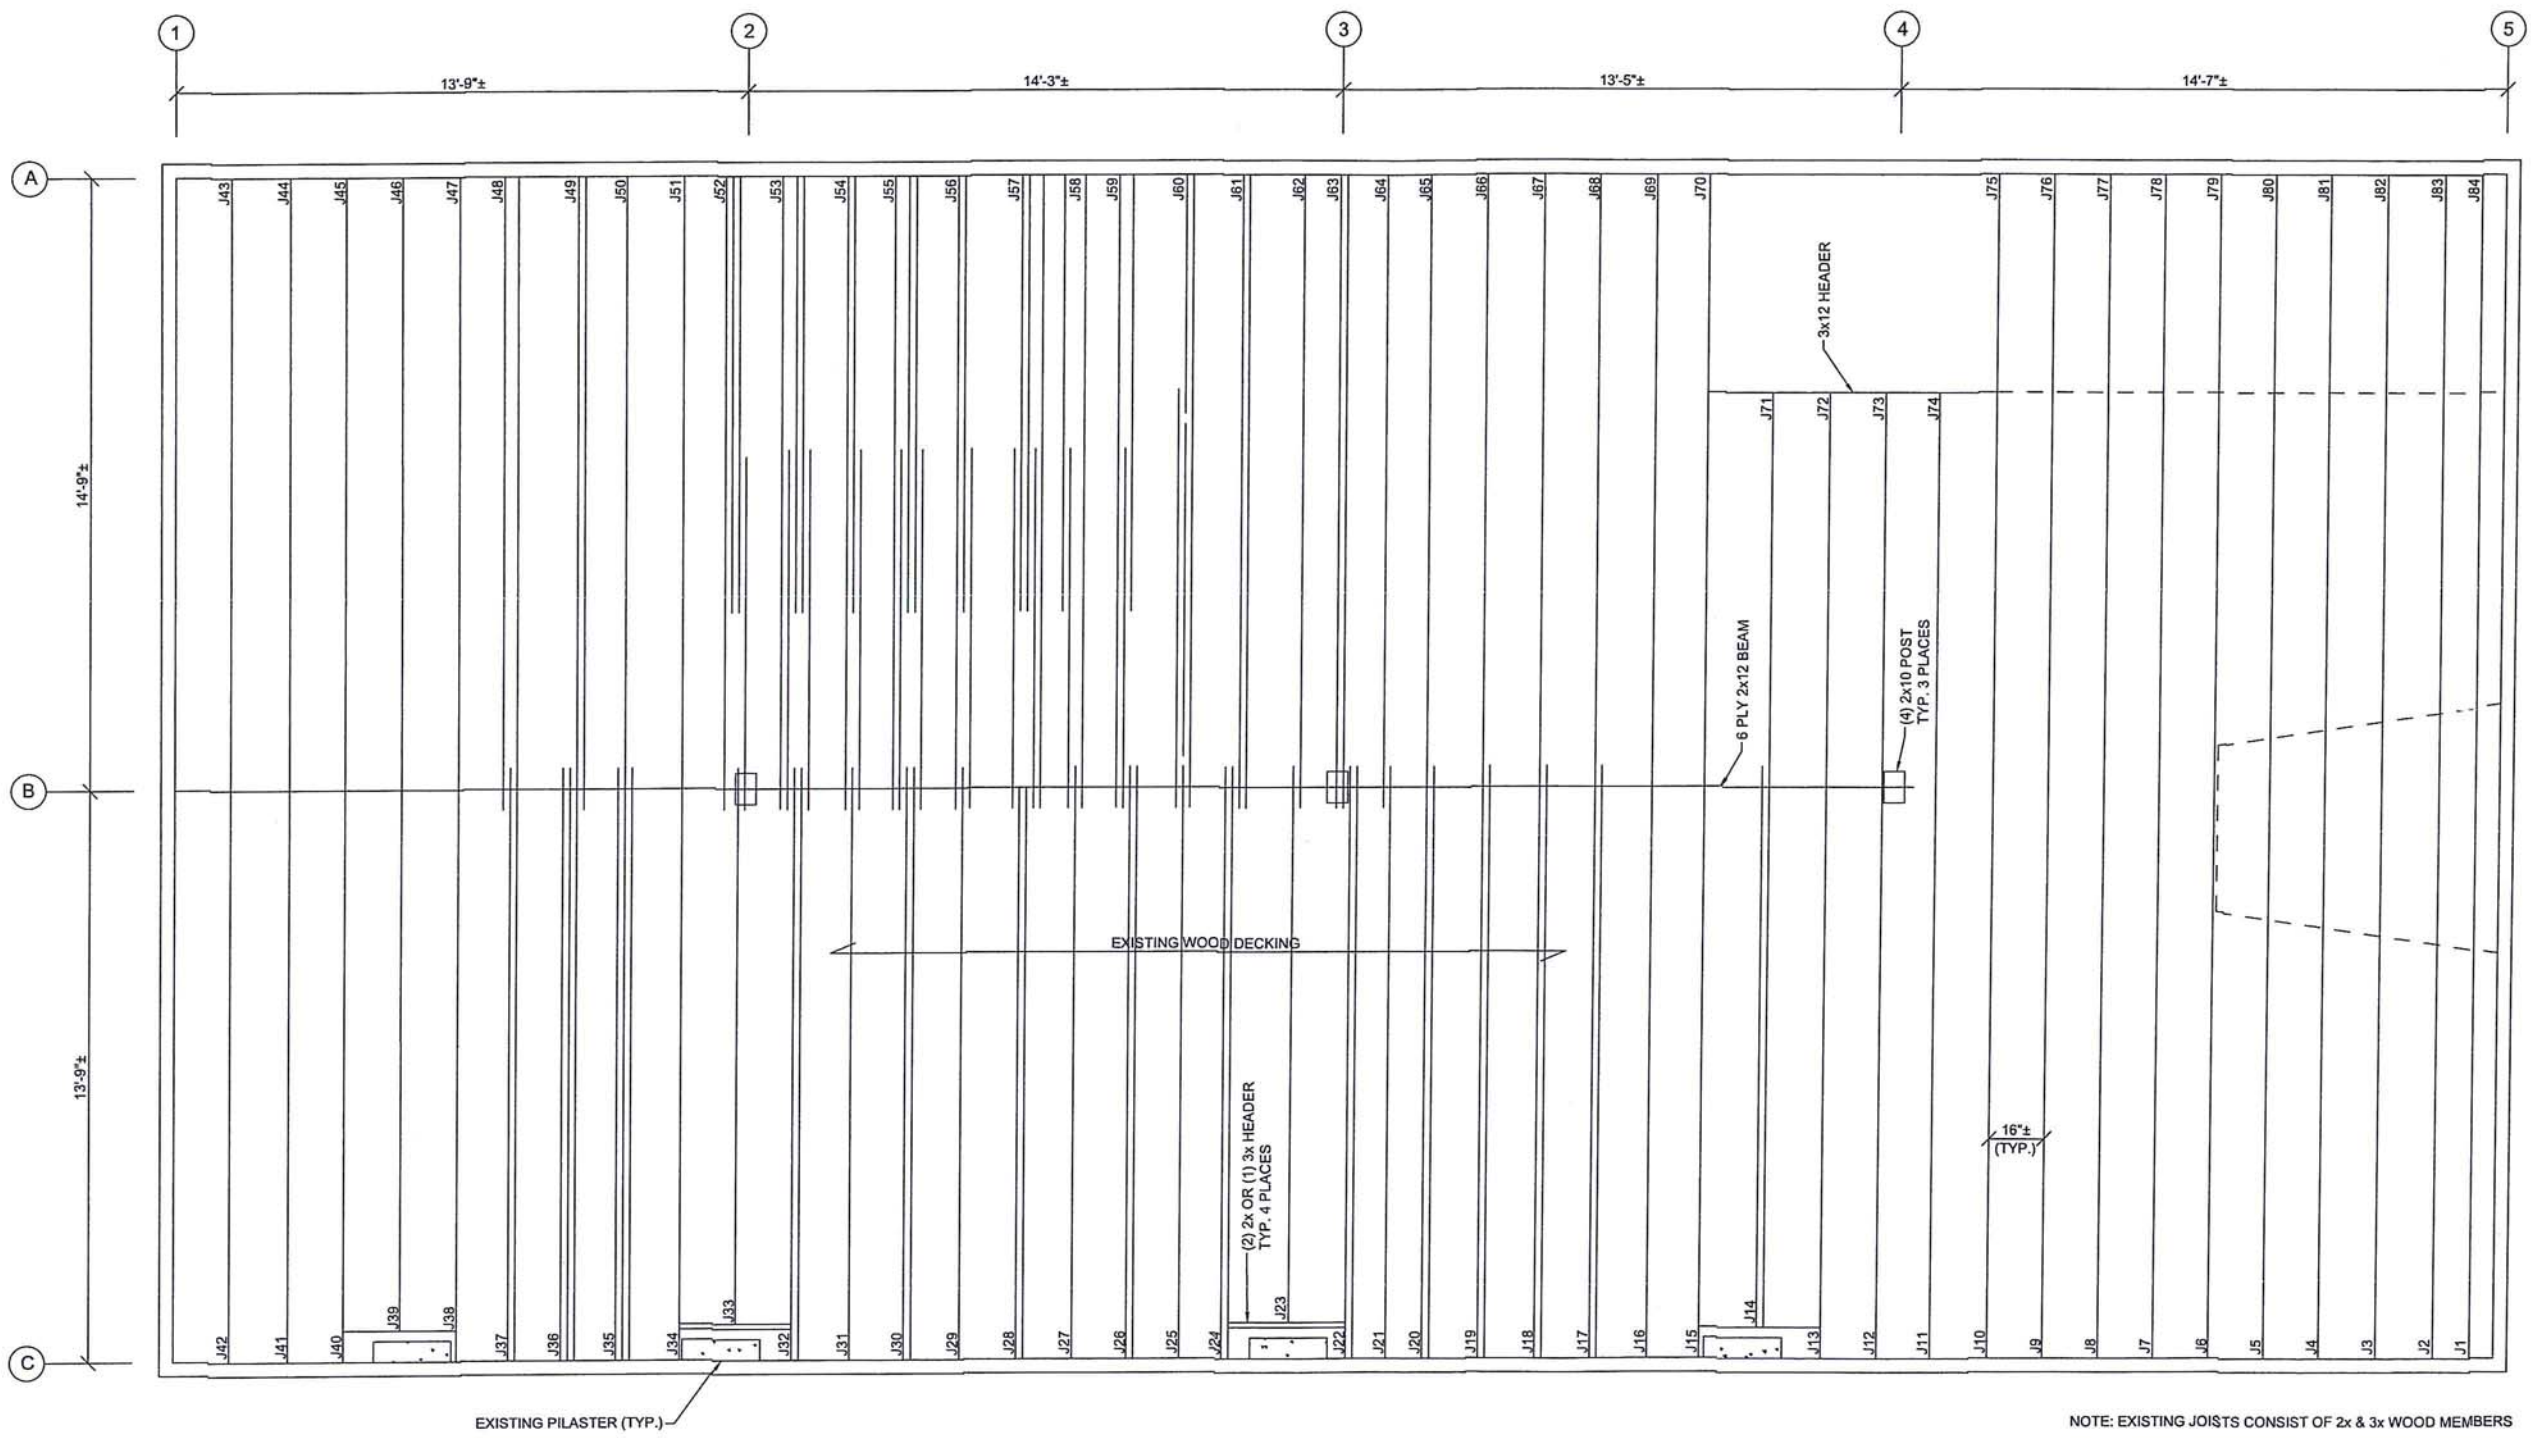
EXISTING SECOND FLOOR FRAMING PLAN

1. A number of the original 3x12 floor joists have failed.
2. A number of the original 3x12 and 2x12 floor joists have been compromised by post installed notches and holes.
3. The floor joists in the central area of the west half of the floor plate were pieced together with partial span members. We highly doubt that the existing splices are adequate to develop the required shear and moment.
4. The post installed 6 ply 2x12 beam spanning in the north-south direction at approximately the middle of the building in the east-west direction is not adequate to support the required dead and live loads.

5. The existing 3x12 joist members in the front of the building spanning from exterior wall to exterior wall are not adequate to support the required dead and live loads.
6. The existing joist sections towards the back of the building on the east side of the 6 ply 2x12 beam line support the load bearing wall on the second floor. These joists are not adequate to support the required dead and live loads.

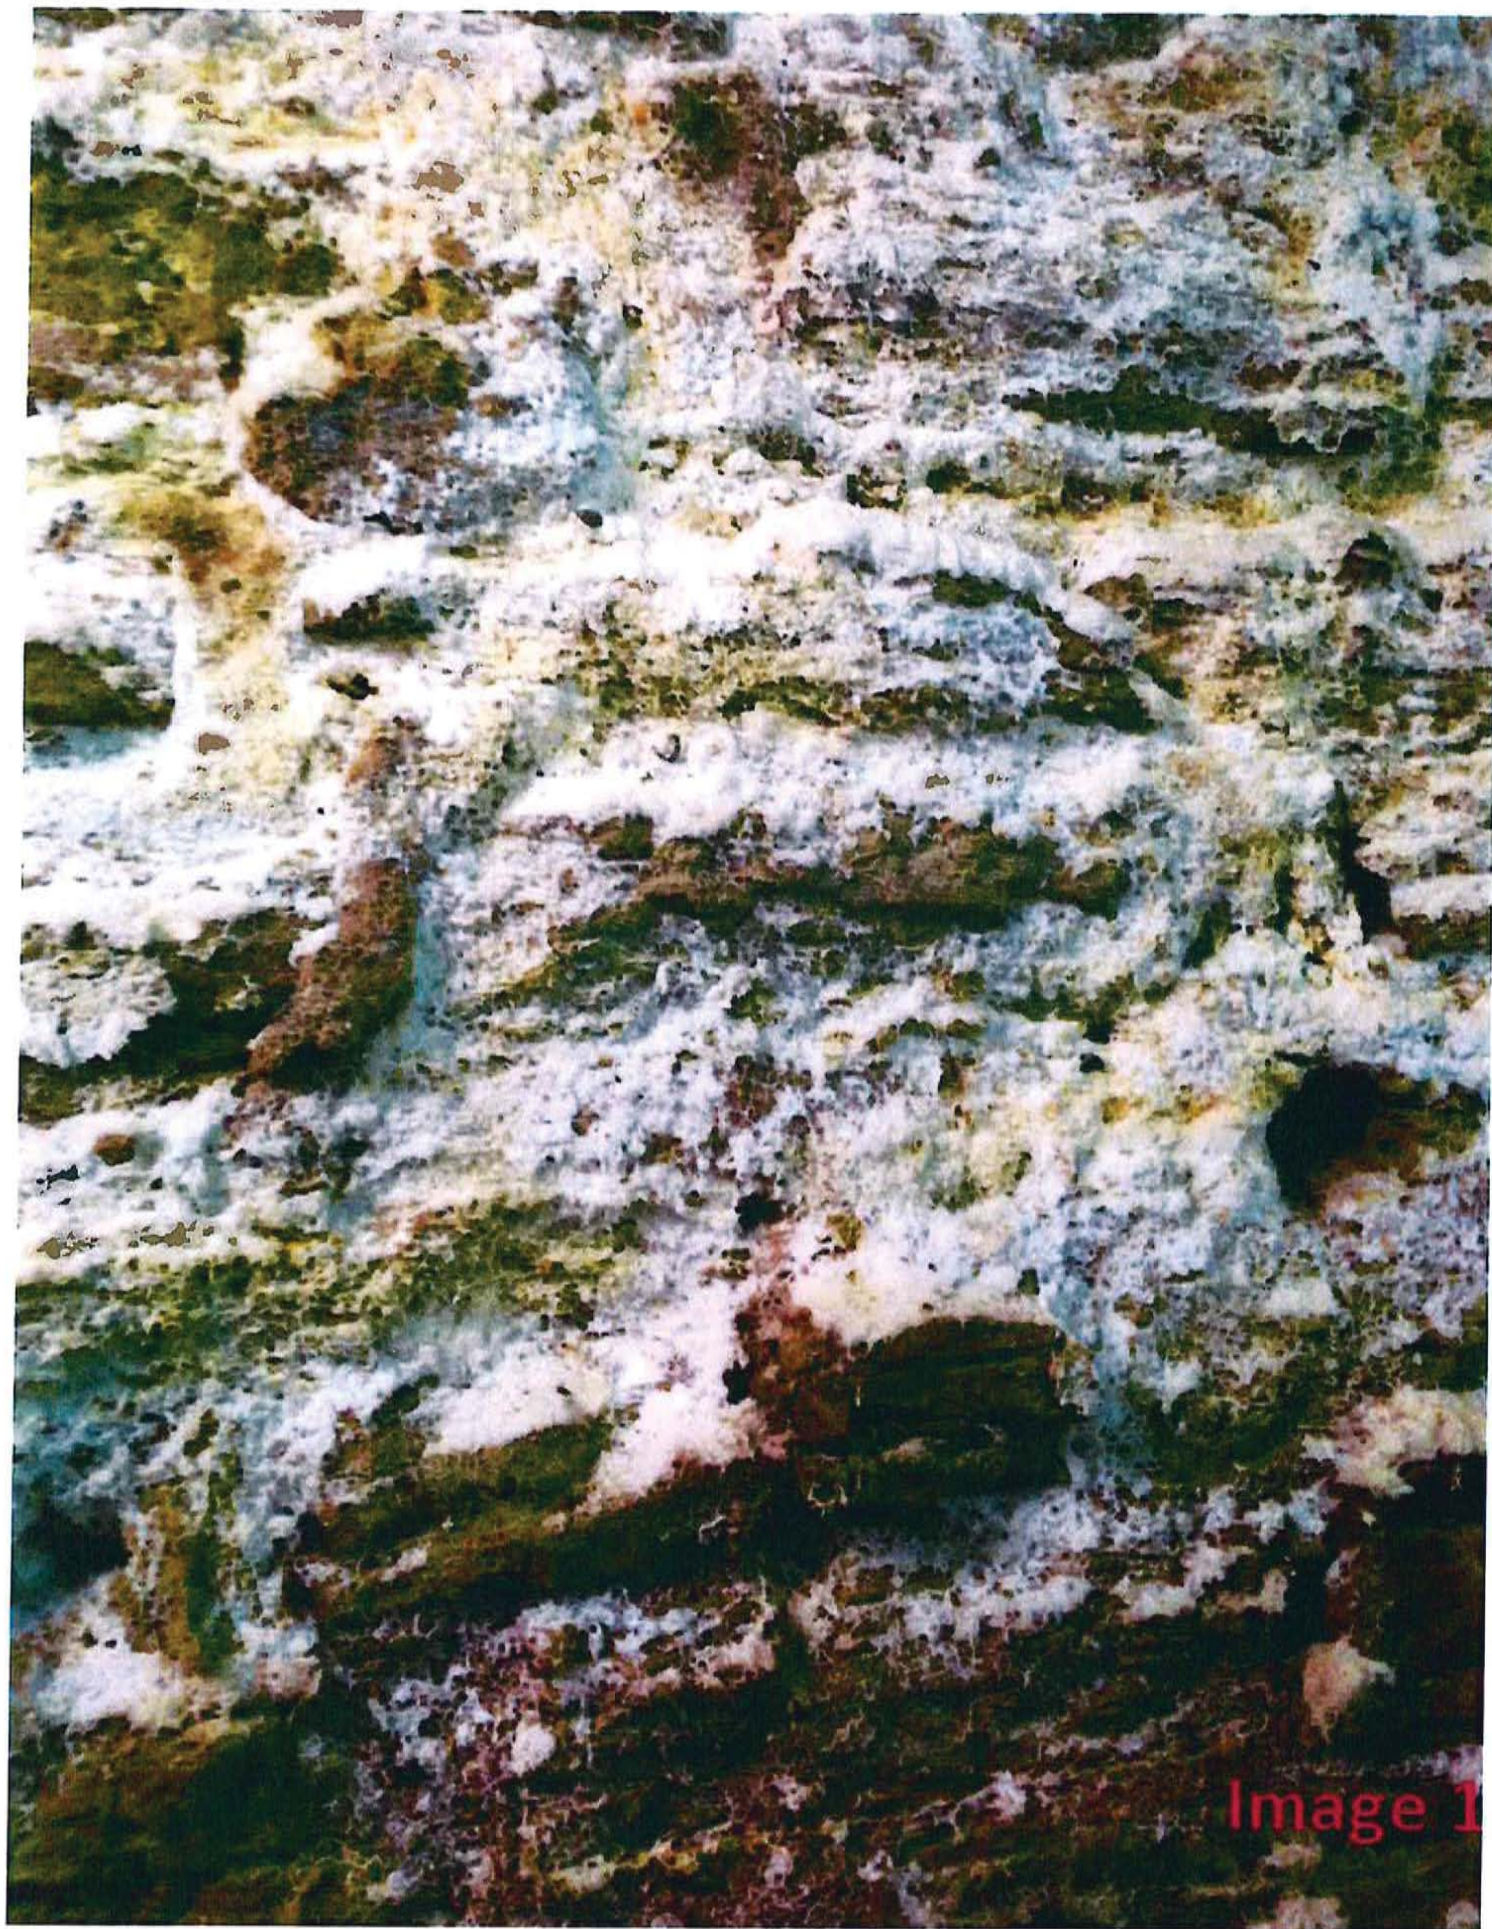
Image 1

- The foundation walls consist primarily of sandstone which appeared to be in generally good condition. Calcium deposits were noted predominantly on the north wall (Image 1) suggesting that moisture has been/is penetrating the foundation wall. A collection of dissolved sandstone/mortar was noted at the base of the wall most notably along the north wall (Image 2) suggesting that some degree of deterioration of the wall has occurred.

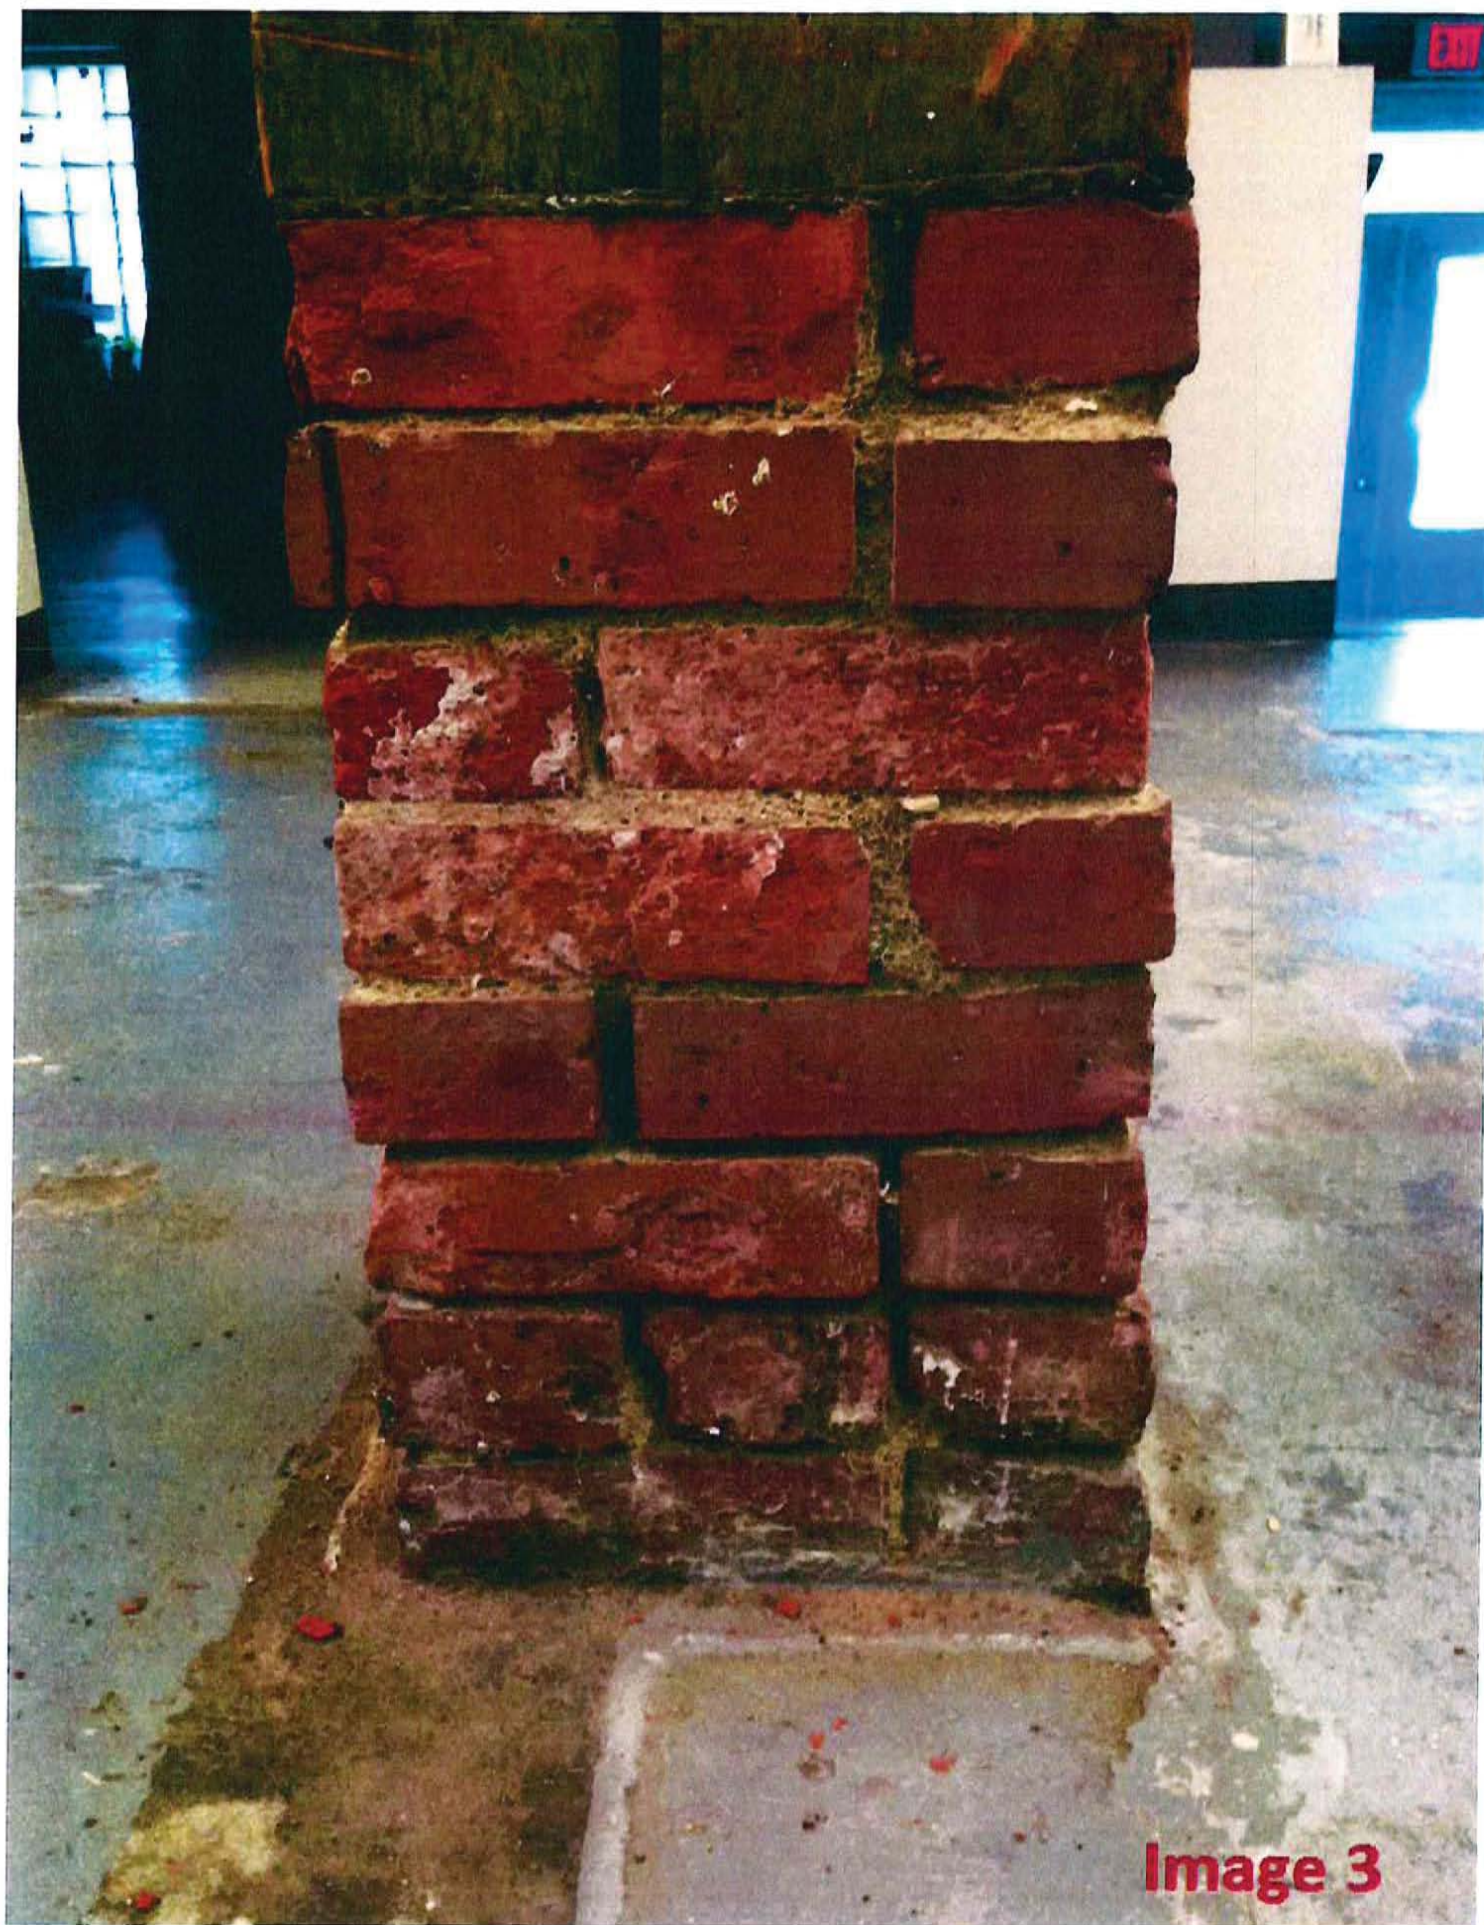
**Image 3**

- Some minor tuckpointing of the foundation walls and the center support column brick base should be considered (Image 3).
- There is a crack in the southeast corner of the foundation wall that could be filled with an epoxy injection product but we would not consider this to be entirely necessary (Image 4).

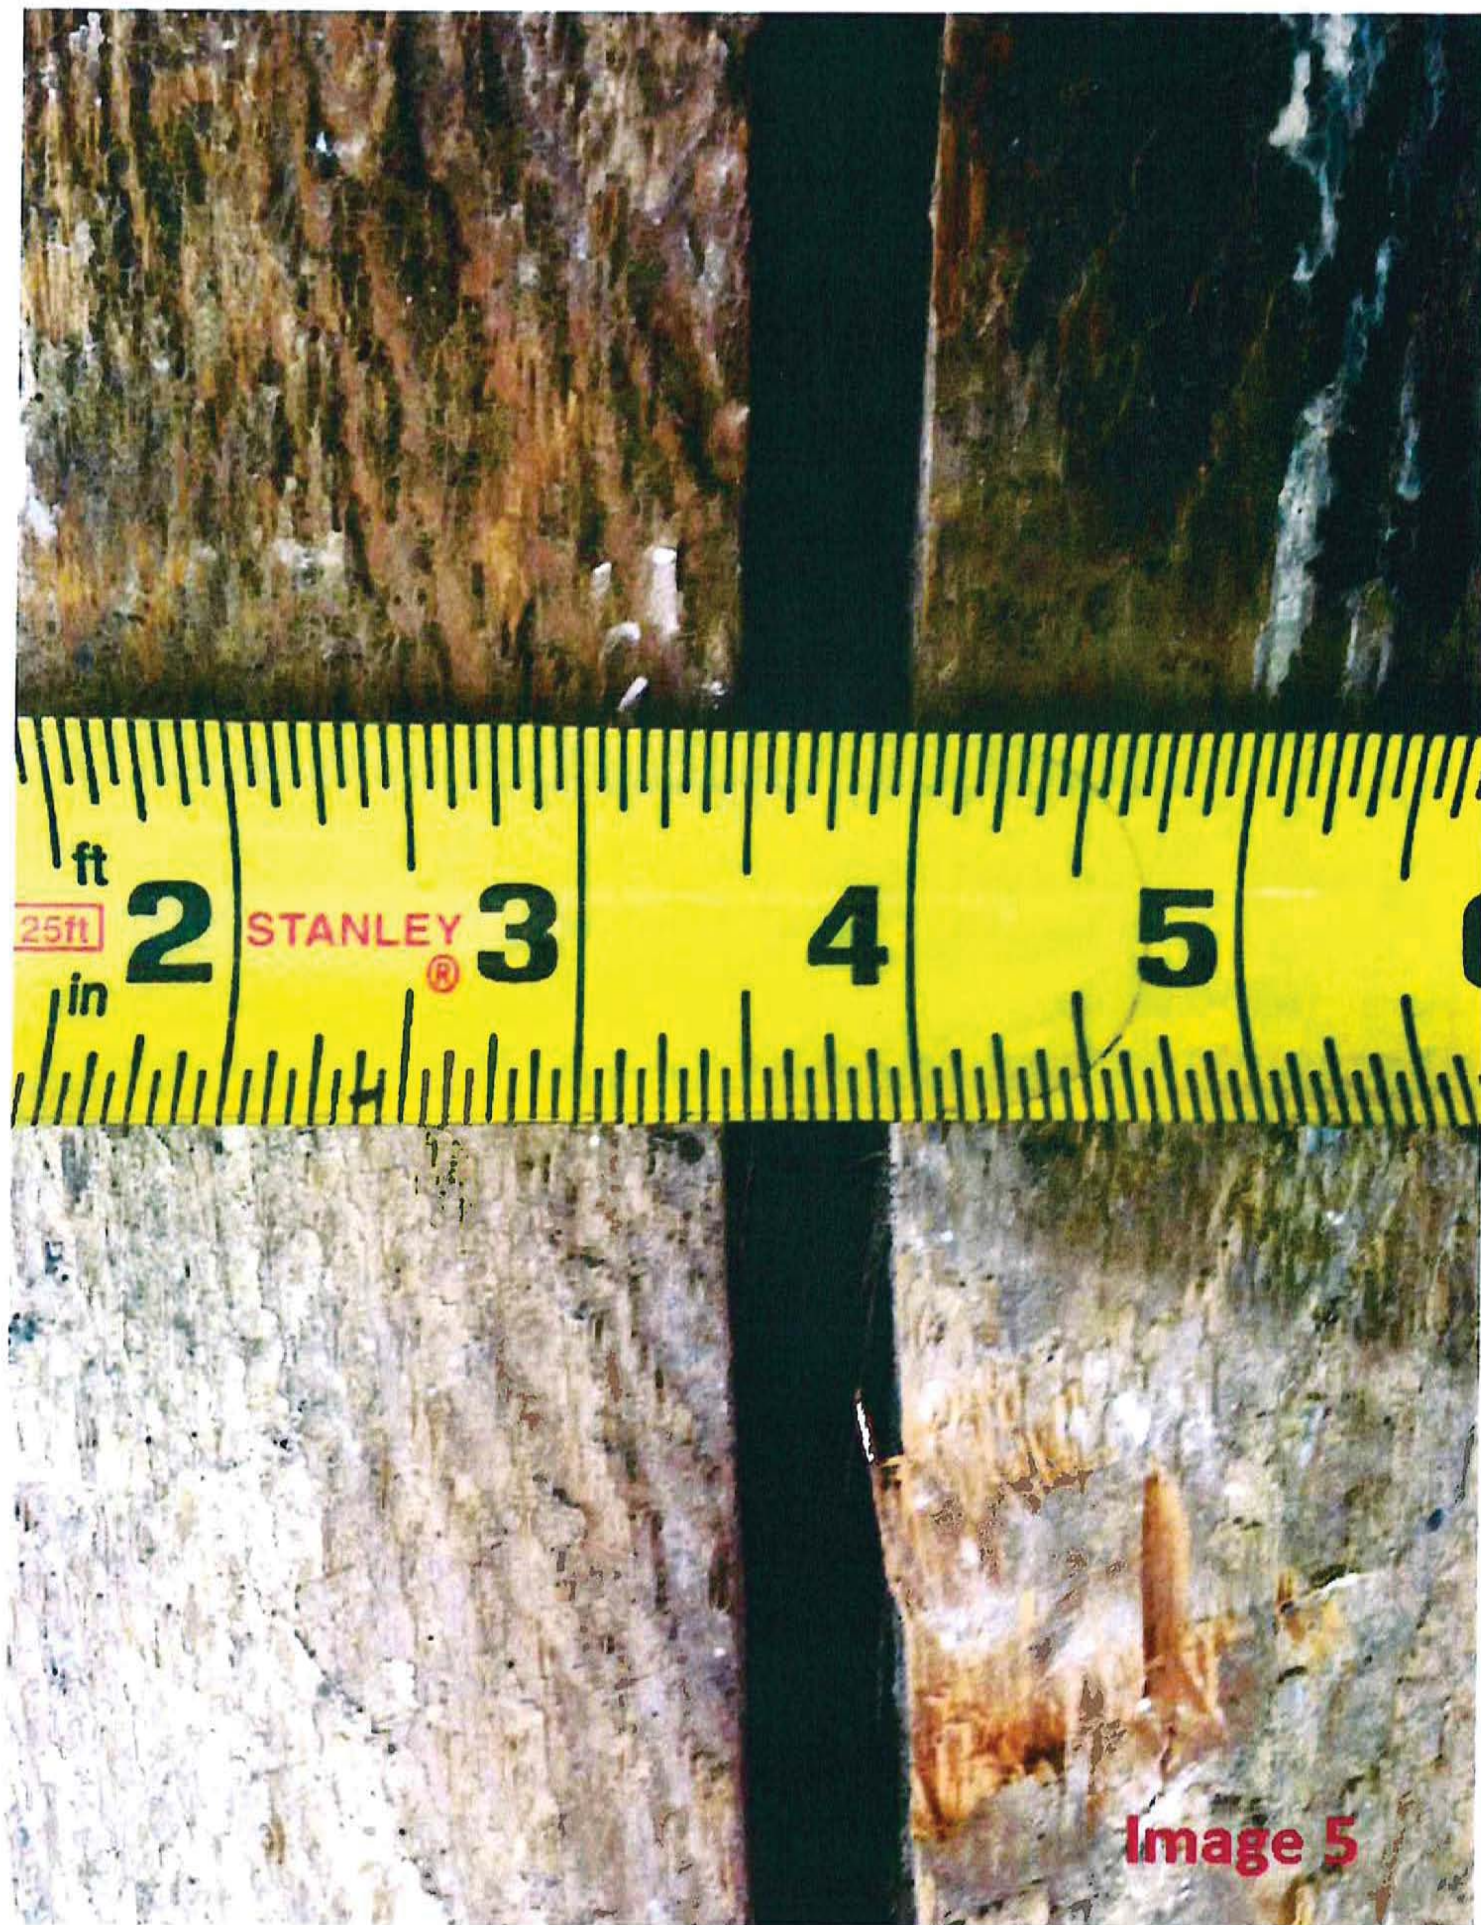
- The center timber column is cracked on the north face (Image 5). This crack is likely due to shrinkage of the wood and not due to stress. This condition should be repaired.
- The concrete slab on grade is in good condition.

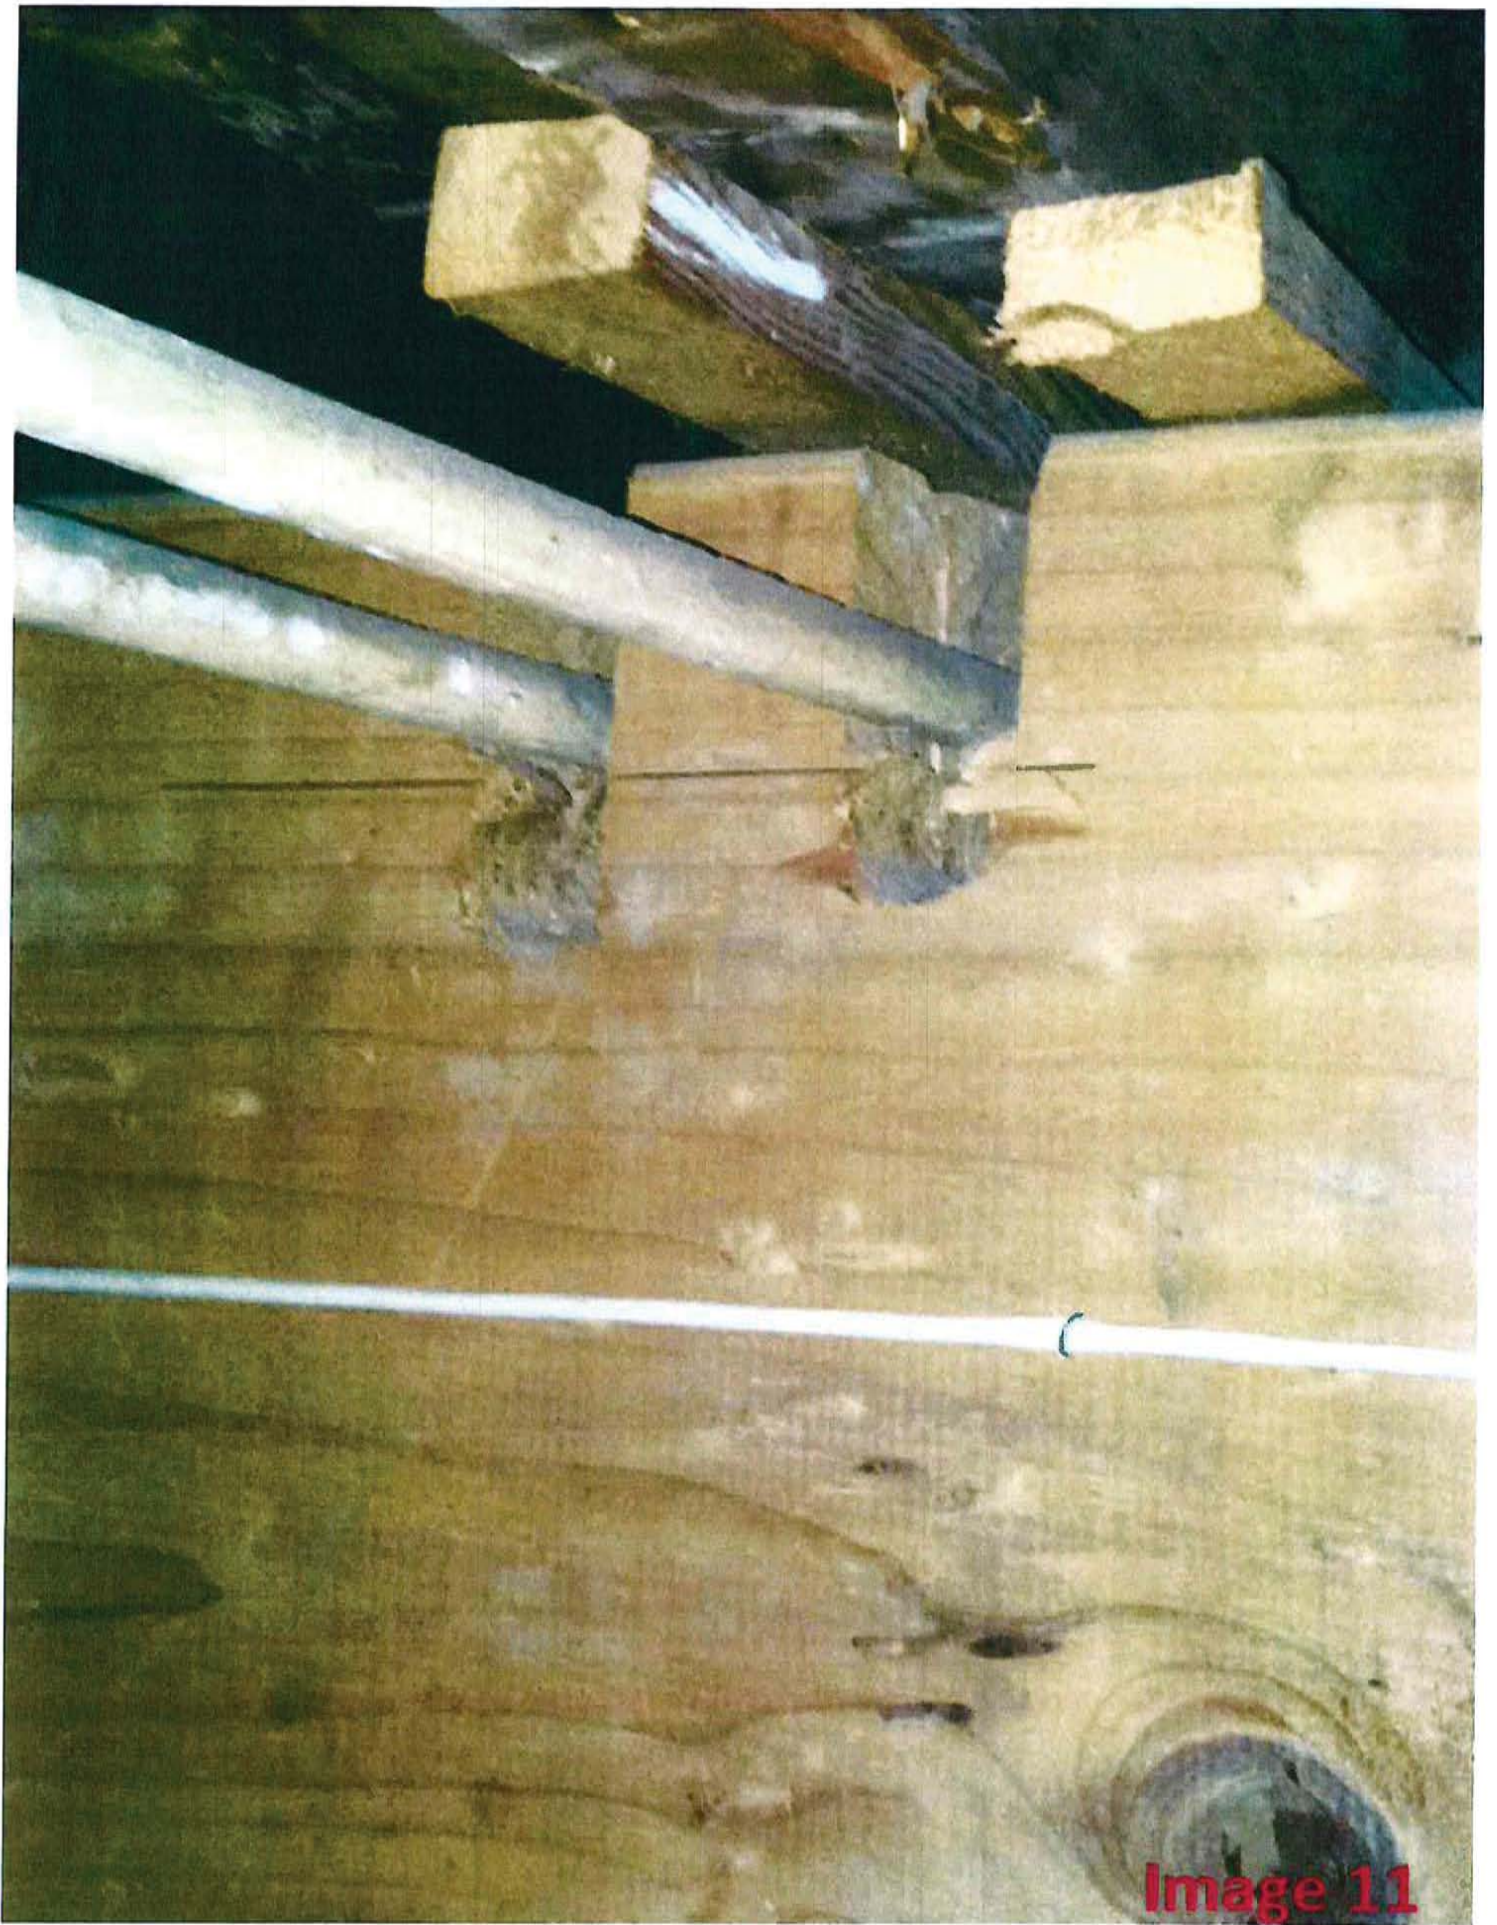
Image 11

- All three spans of the six ply 2x12 beam have been notched at the top reducing the effective section of the members (Images 11 & 12). The adequacy of the remaining sections should be evaluated.

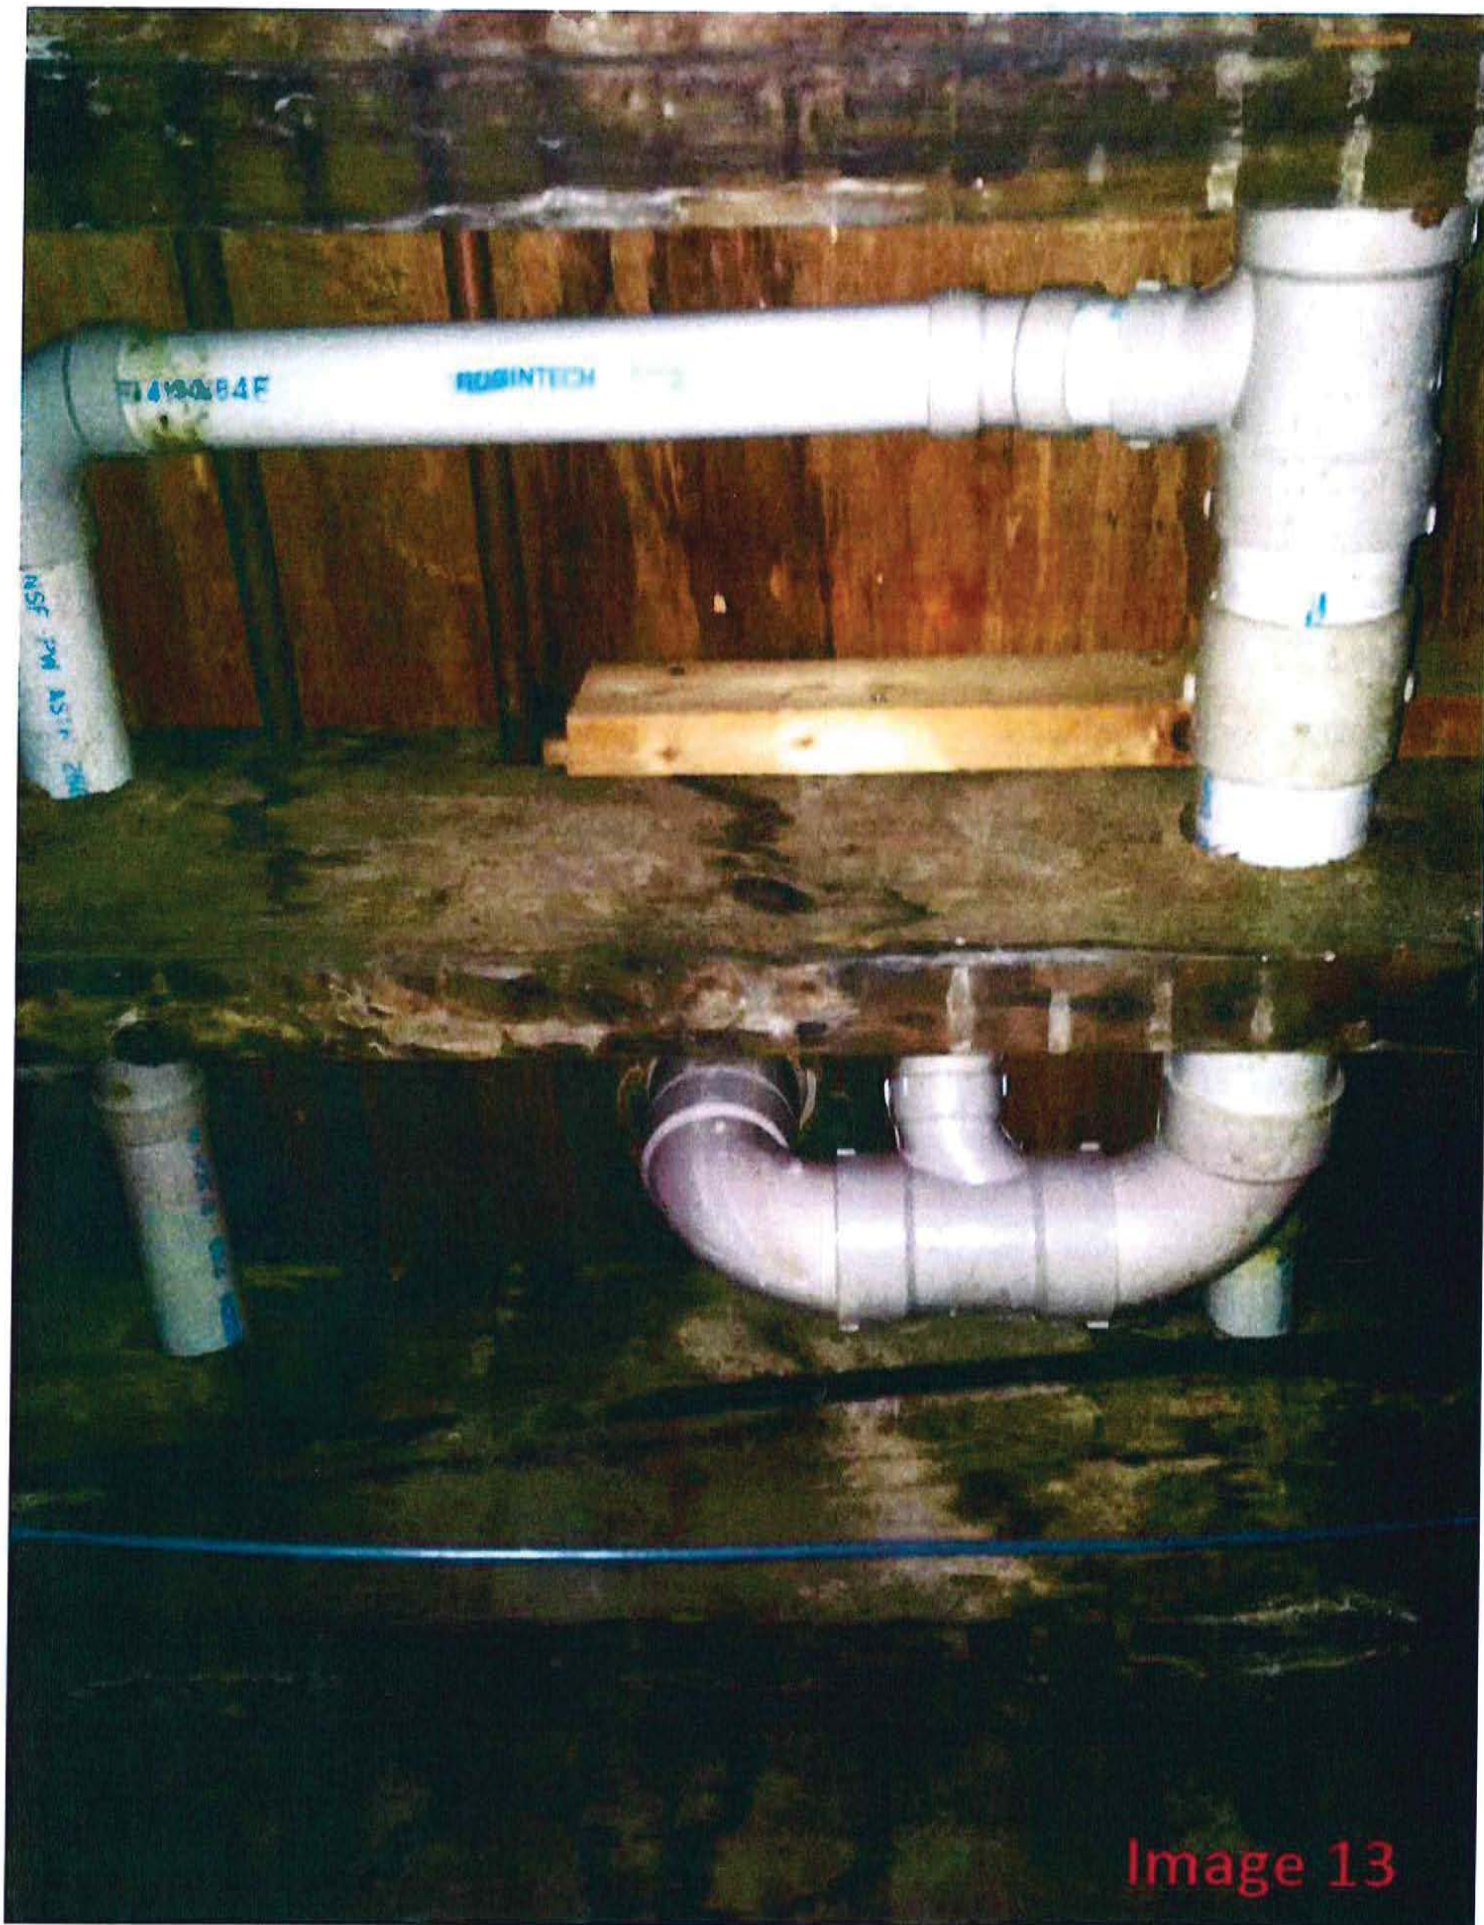
Image 13

- Multiple joists on the east side of the "new" six ply 2x12 beam particularly in the middle third of the floor plate have been either notched for piping, cored for plumbing lines or both. Each of these events results in a reduced effective section of the member (Images 13, 14, 15 & 16). The adequacy of the remaining sections should be evaluated.
