**PRELIMINARY OPINION of PROBABLE COST - DETAIL**  
**RENOVATE 200 MAIN STREET BUILDING**  
**WEST CHICAGO, ILLINOIS**  
**MATOCHA PROJECT NO.: 1506.01**  
**DATE: NOVEMBER 9, 2015**

**STRUCTURAL REPAIRS**

Re: 200 W. Main Street  
West Chicago, Illinois

On August 12, 2015 we visited the above referenced site to observe the structural condition of the above referenced building. The structure consists of a three story wood framed structure with perimeter load-bearing masonry walls. The following is an itemized list of our observations.

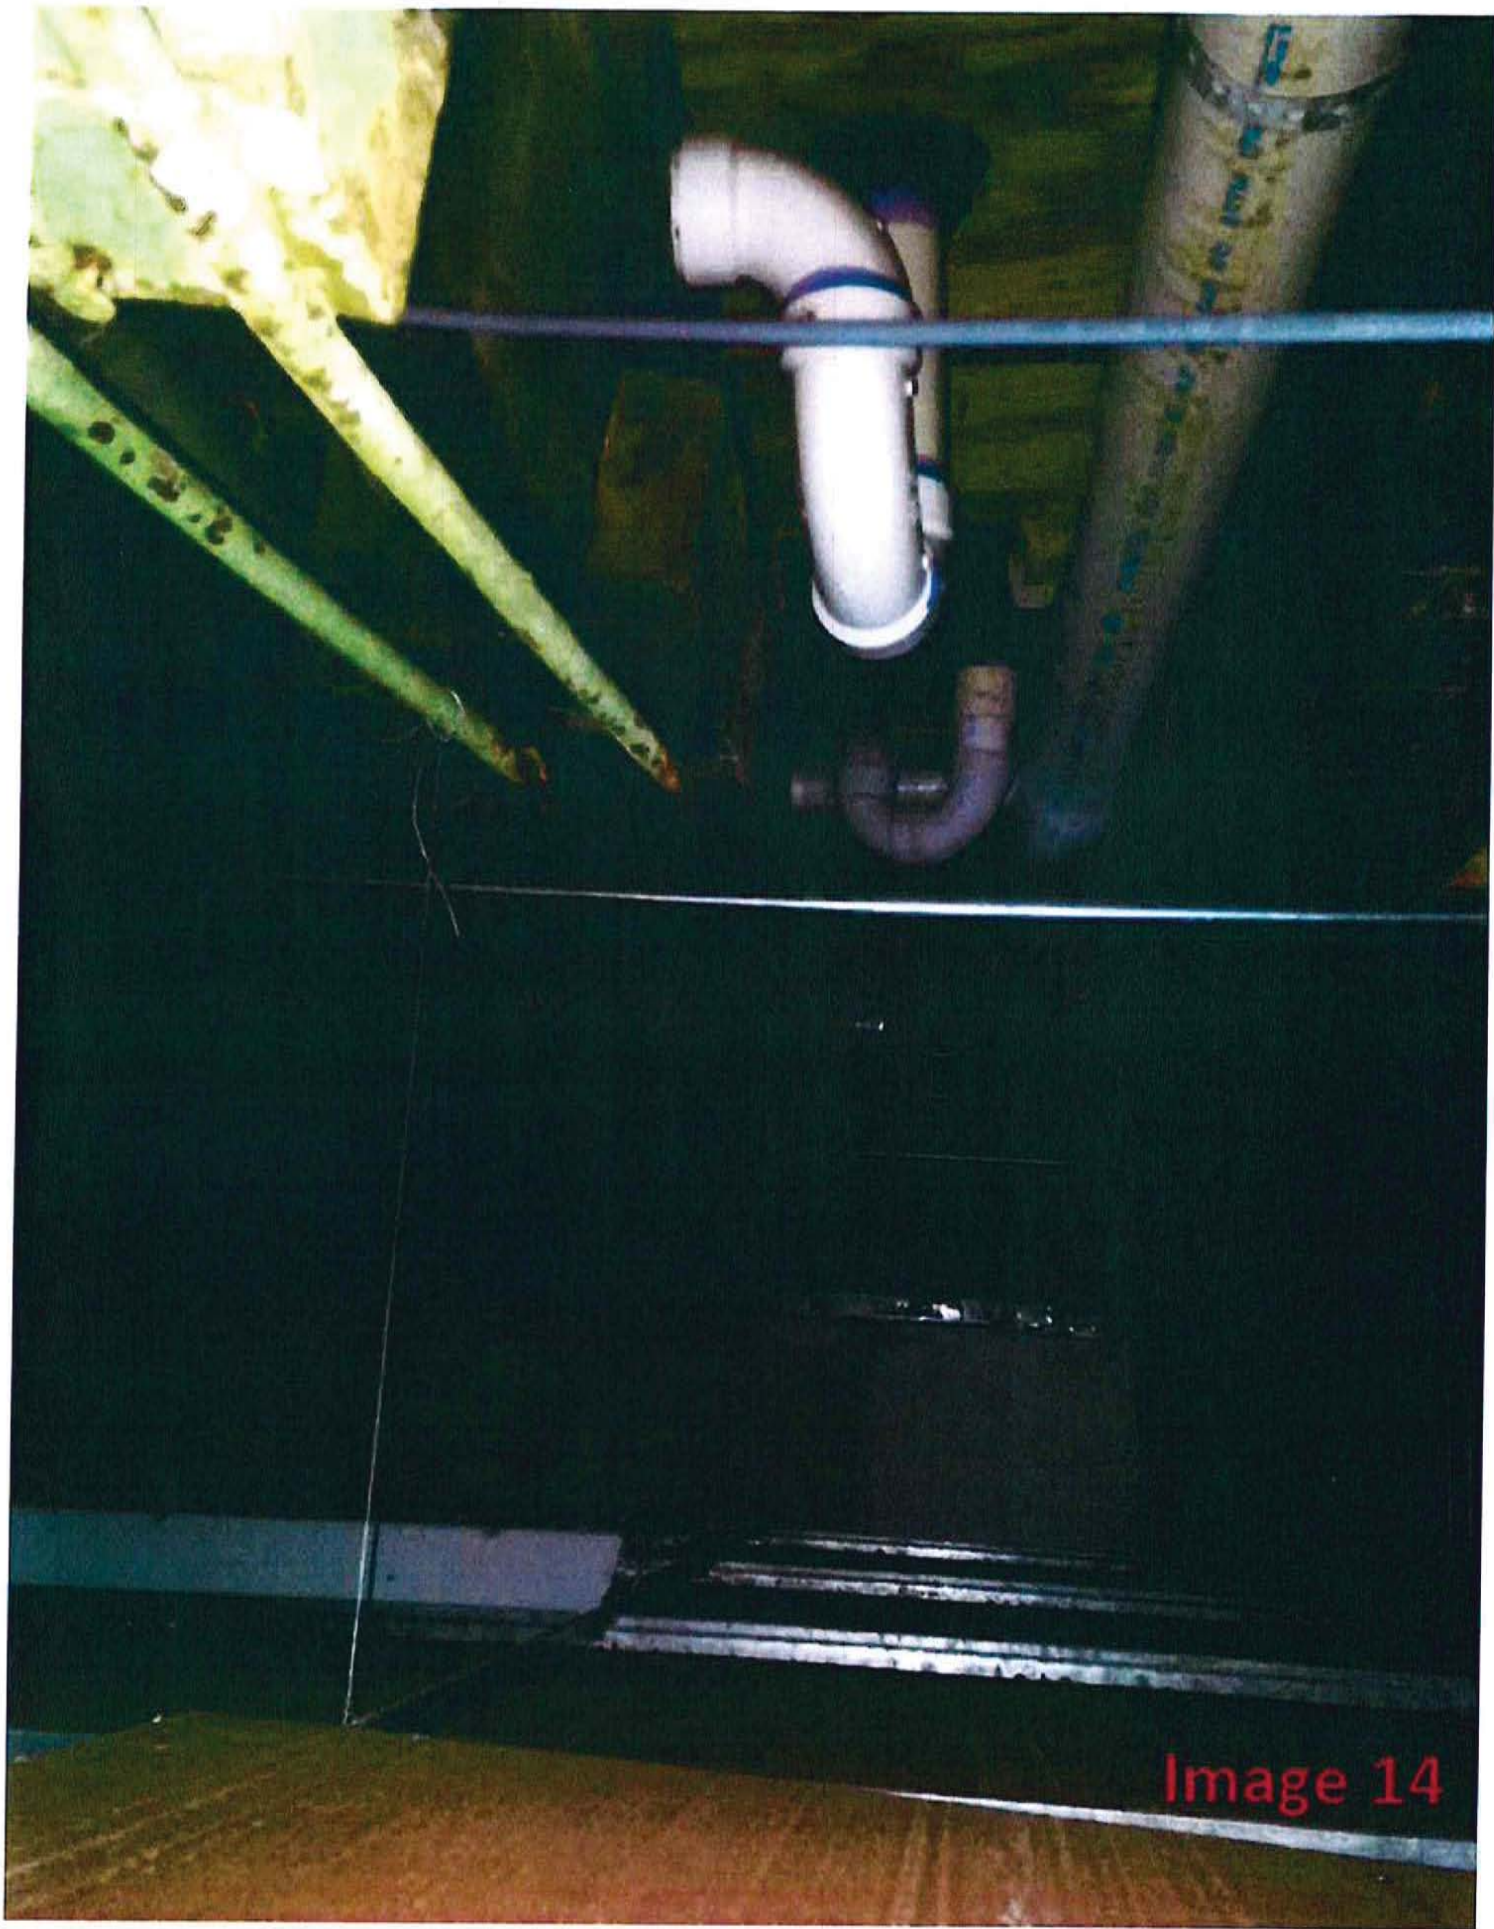
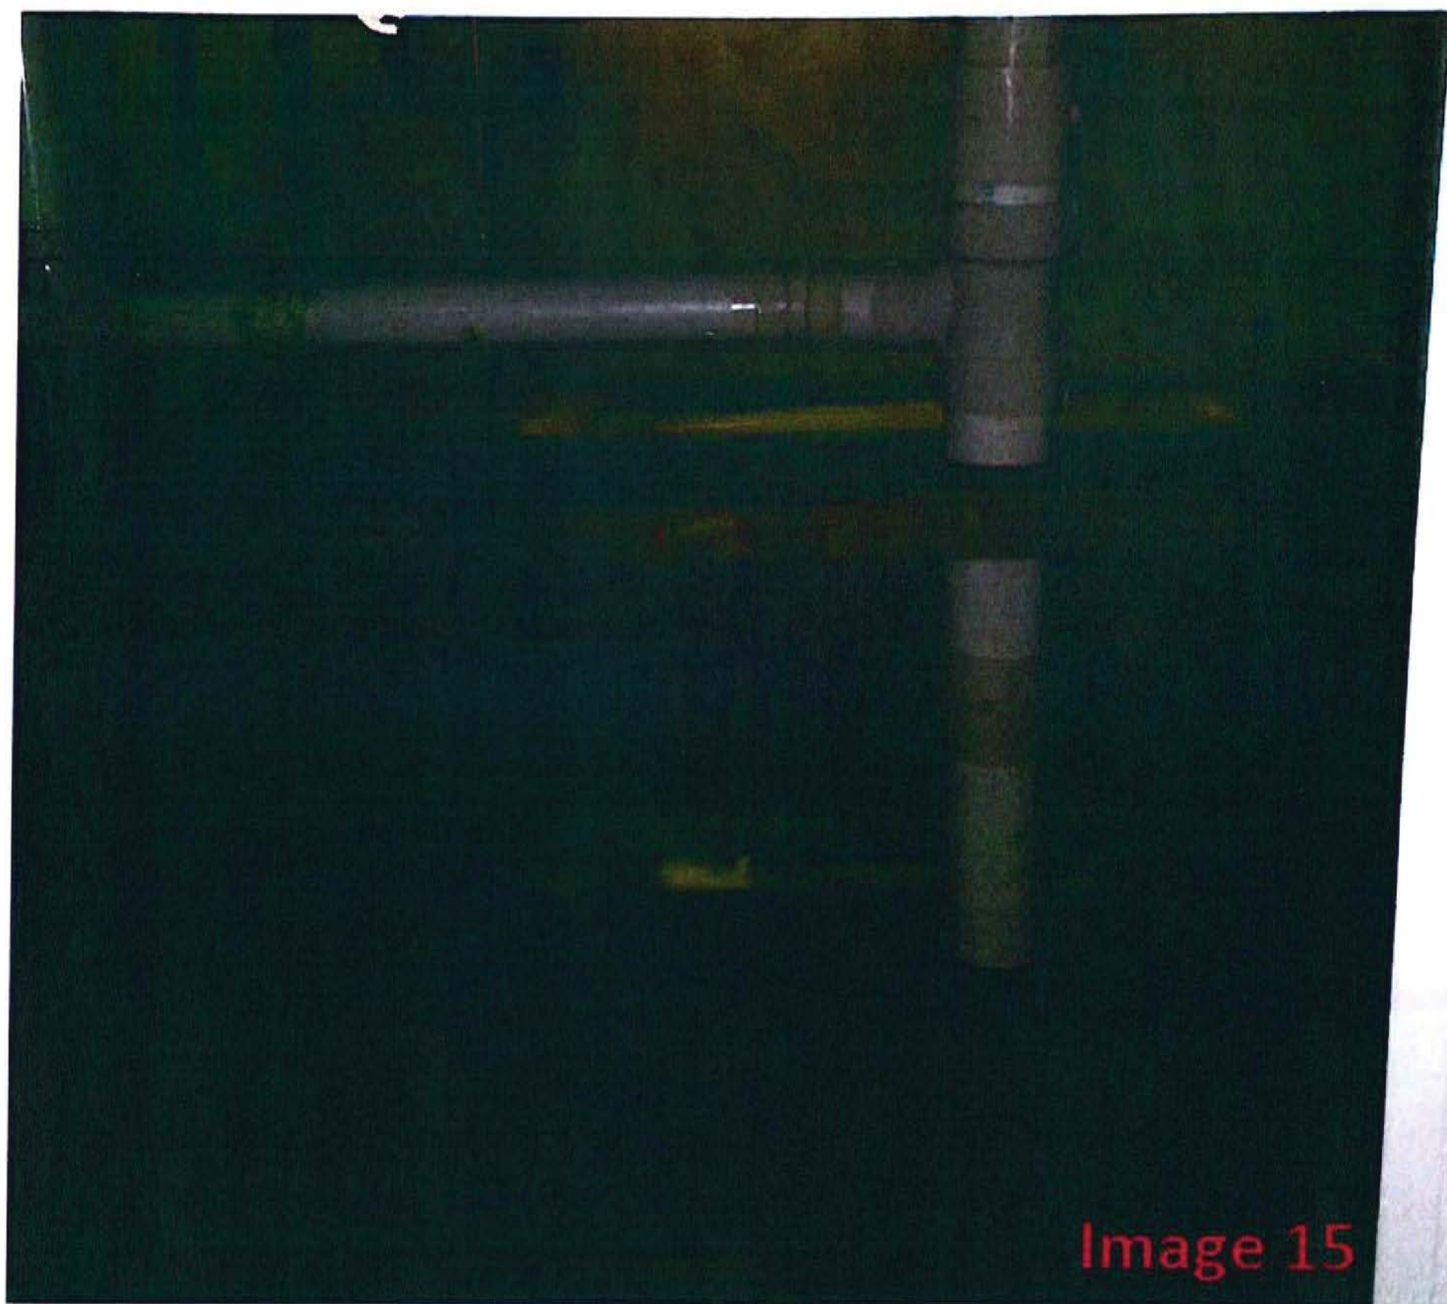
- Multiple joists on the east side of the "new" six ply 2x12 beam particularly in the middle third of the floor plate have been either notched for piping, cored for plumbing lines or both. Each of these events results in a reduced effective section of the member (Images 13, 14, 15 & 16). The adequacy of the remaining sections should be evaluated.

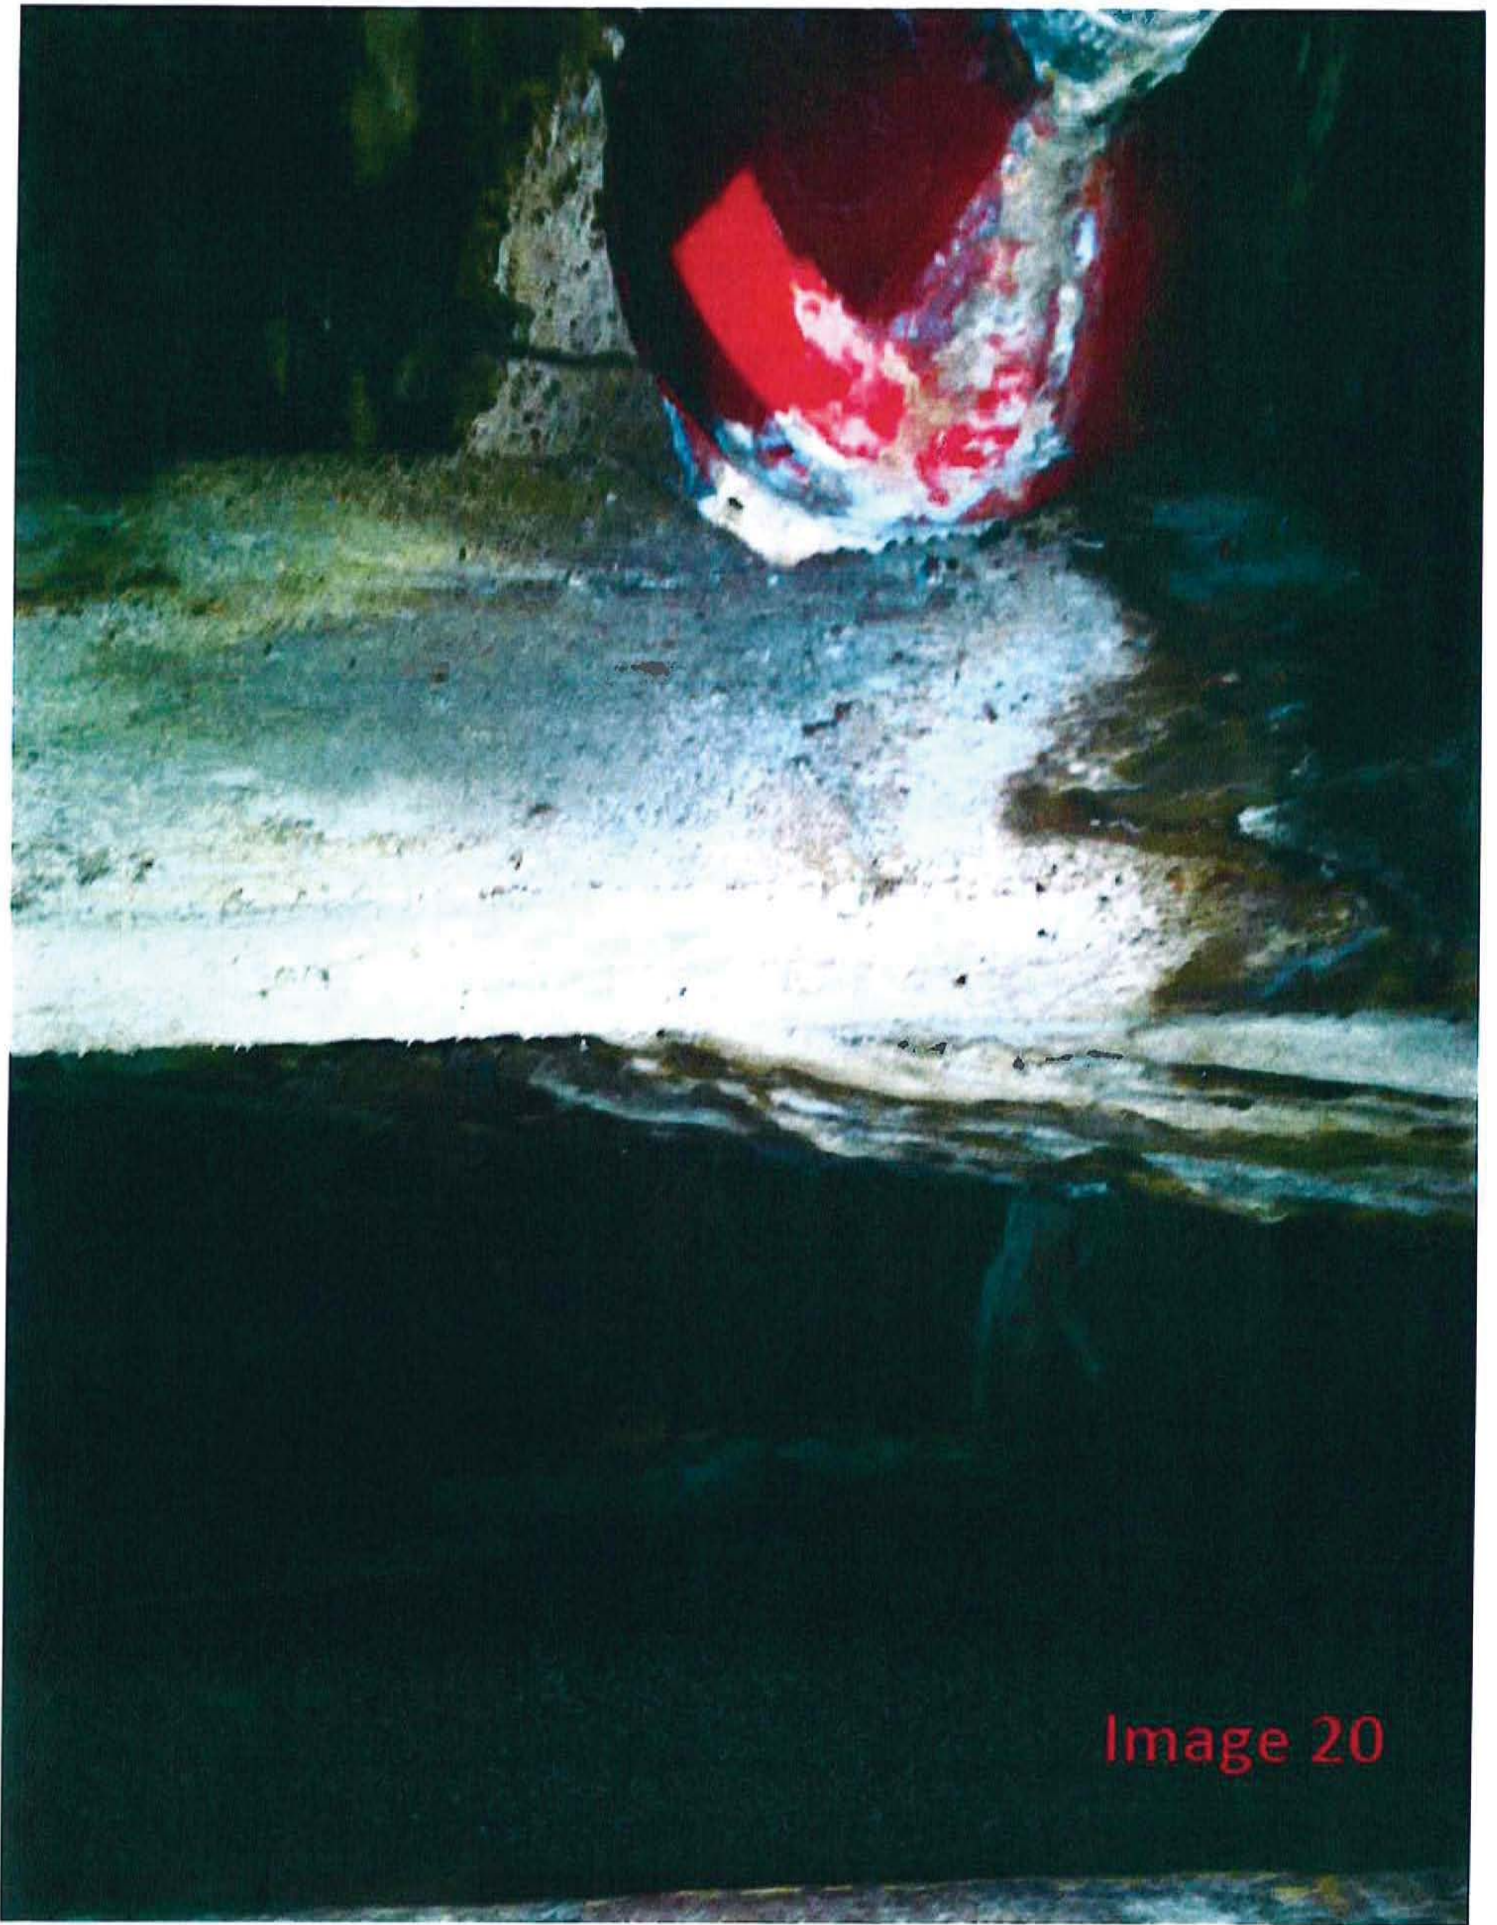
Image 20

- The roof framing consists of 2x10 rafters spaced at 18" on center spanning from both exterior masonry walls to both of the hallway stud framed walls. The 2x10 rafters slope from the exterior walls to a low point at approximately the east-west centerline of the building. Based on very limited access to this framing it appeared to be in good condition with the exception of an area near the back of the building where water damage was noted (Image 20). The roof should be inspected by a qualified roofing contractor to establish areas in need of repair.

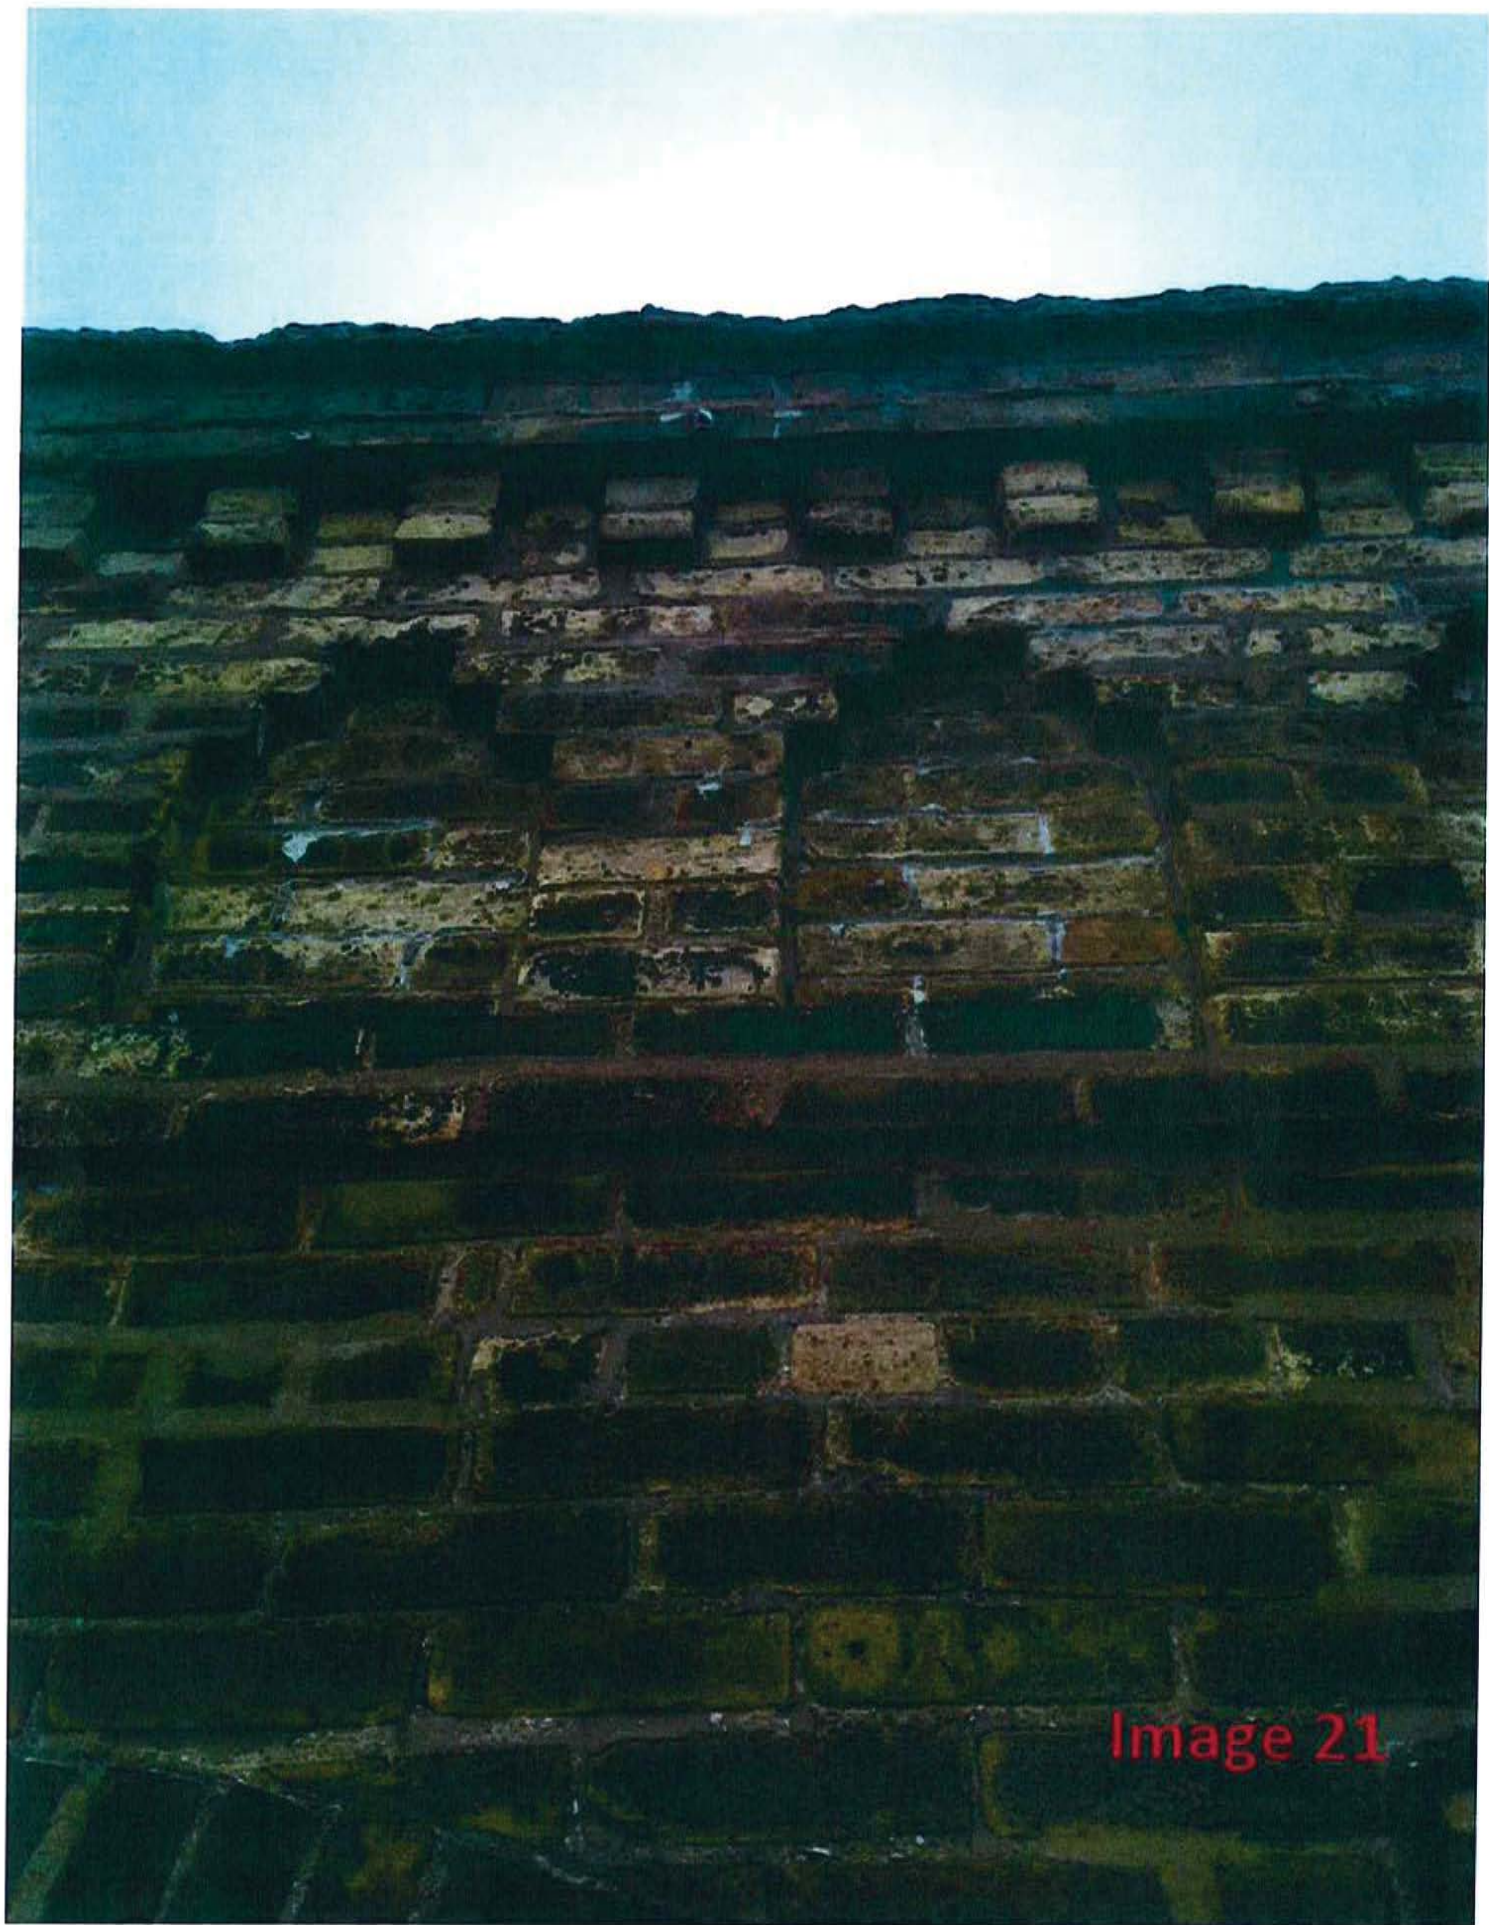
Image 21

- The masonry parapet walls are generally in good condition (Images 21 & 22). There are some joints that should be tuckpointed
