IL Rte. 59 at Washington Street
West Chicago, IL

- RLR Photo Enforcement System monitors violations occurring on the northbound approach of the intersection
- RLR Photo Enforcement System installed: March 23, 2009

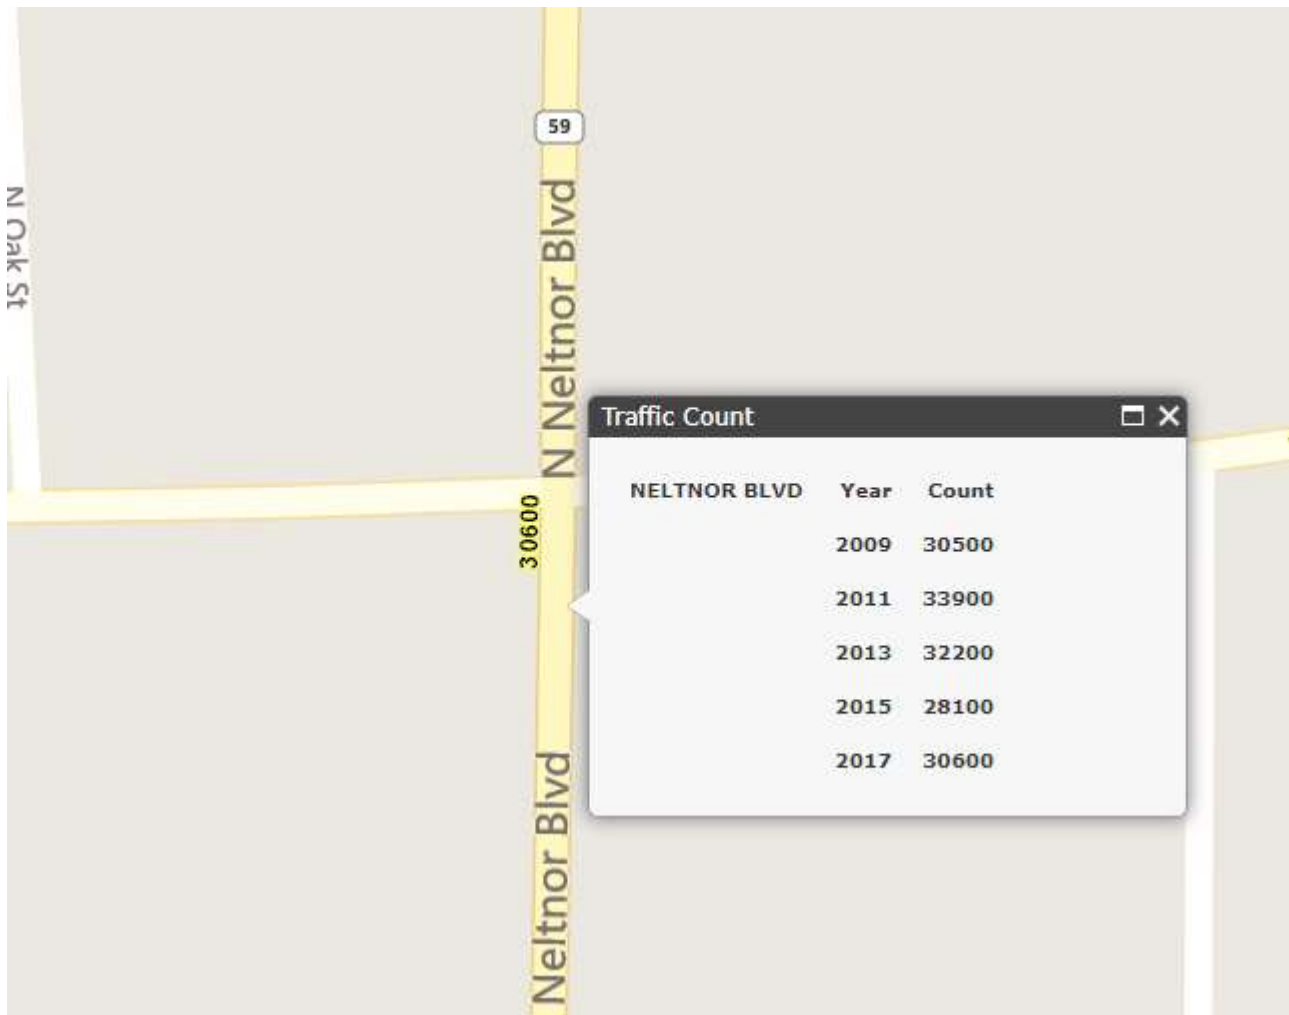
IL Rte. 59 at Washington Street -(Northbound/Southbound)

- 30,500 (2009)
- 33,900 (2011)
- 32,200 (2013)
- 28,100 (2015)
- 30,600 (2017)

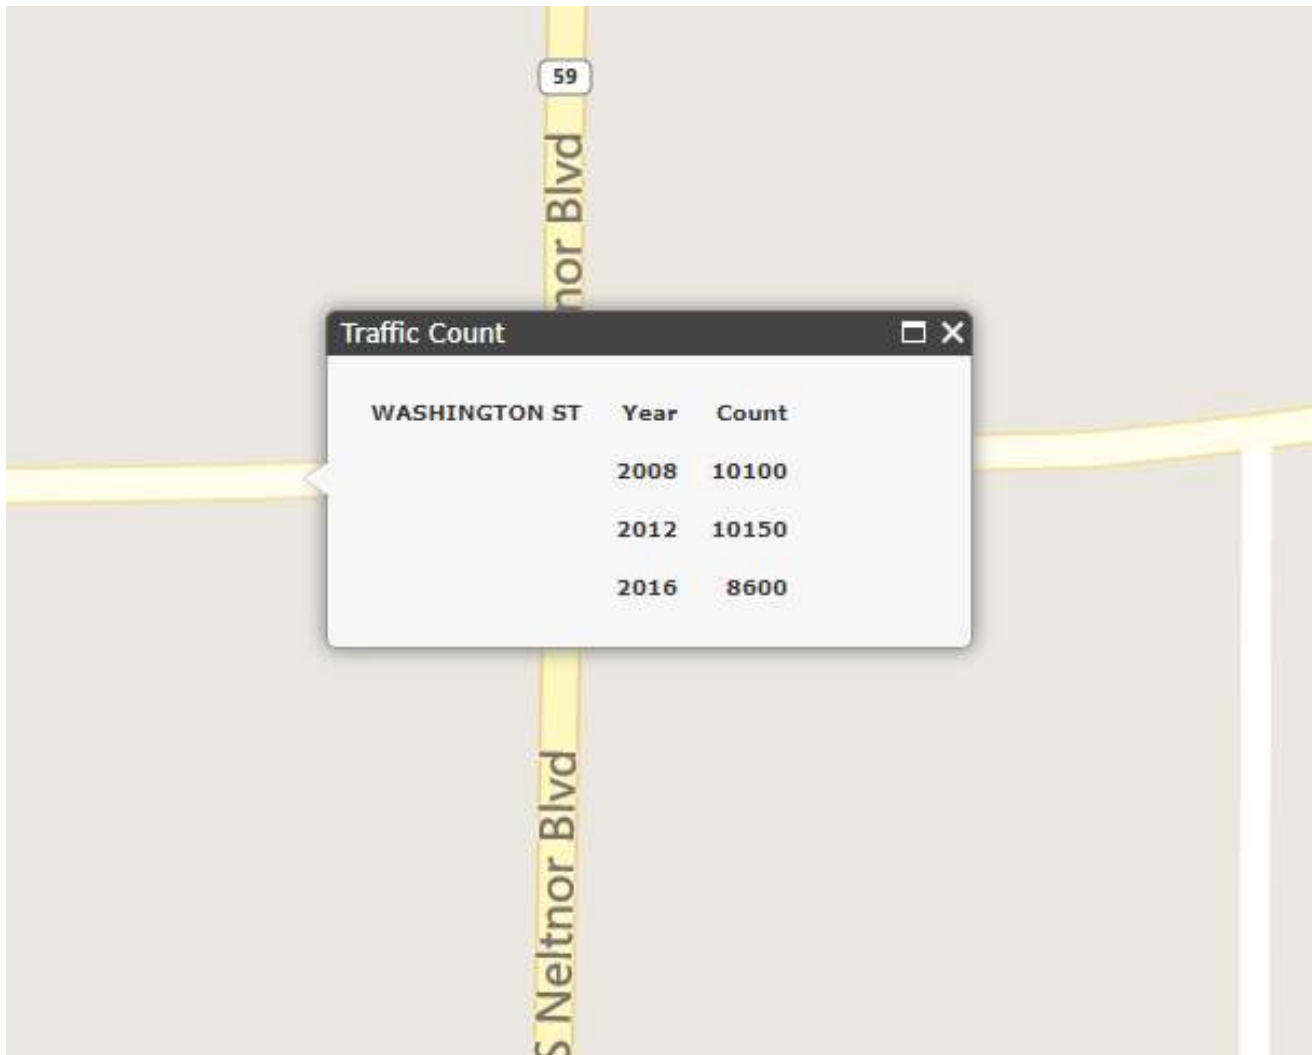
IL Rte. 59 at Washington Street -(Eastbound)

- 10,100 (2008)
- 10,150 (2012)
- 8,600 (2016)

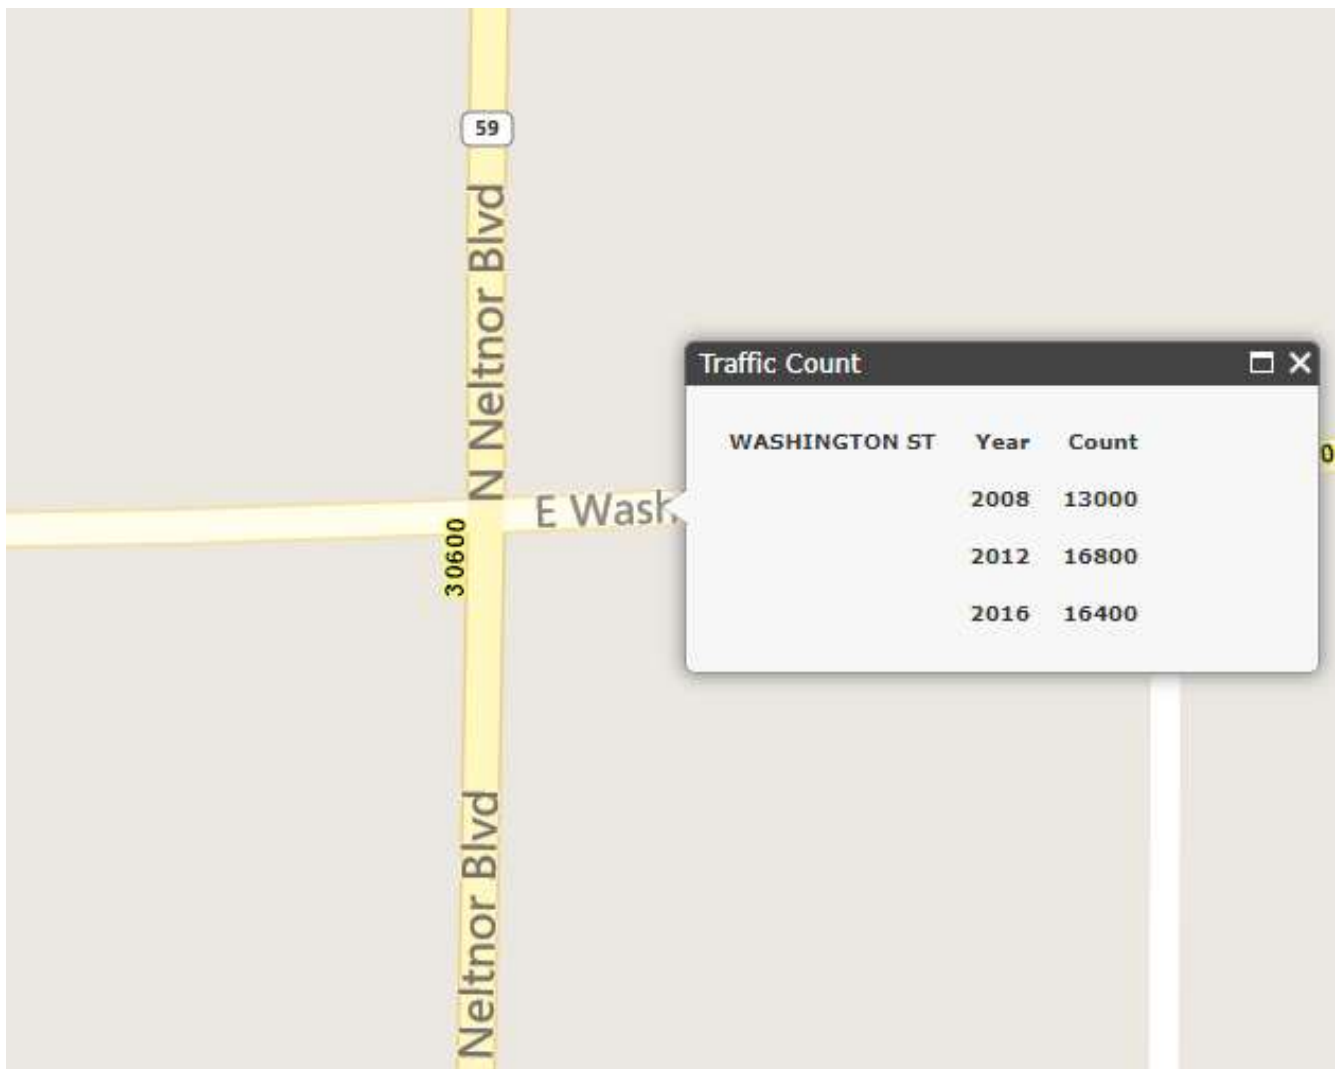
IL Rte. 59 at Washington Street -(Westbound)

- 13,000 (2008)
- 16,800 (2012)
- 16,400 (2016)
